# HOME INSPECTION SERVICES INC.

10 Hunters Creek Dr  
Huntsville, TX 77340  
08/26/2022 9:30 am

Inspector  
Raymond Bennett  
TREC#24071

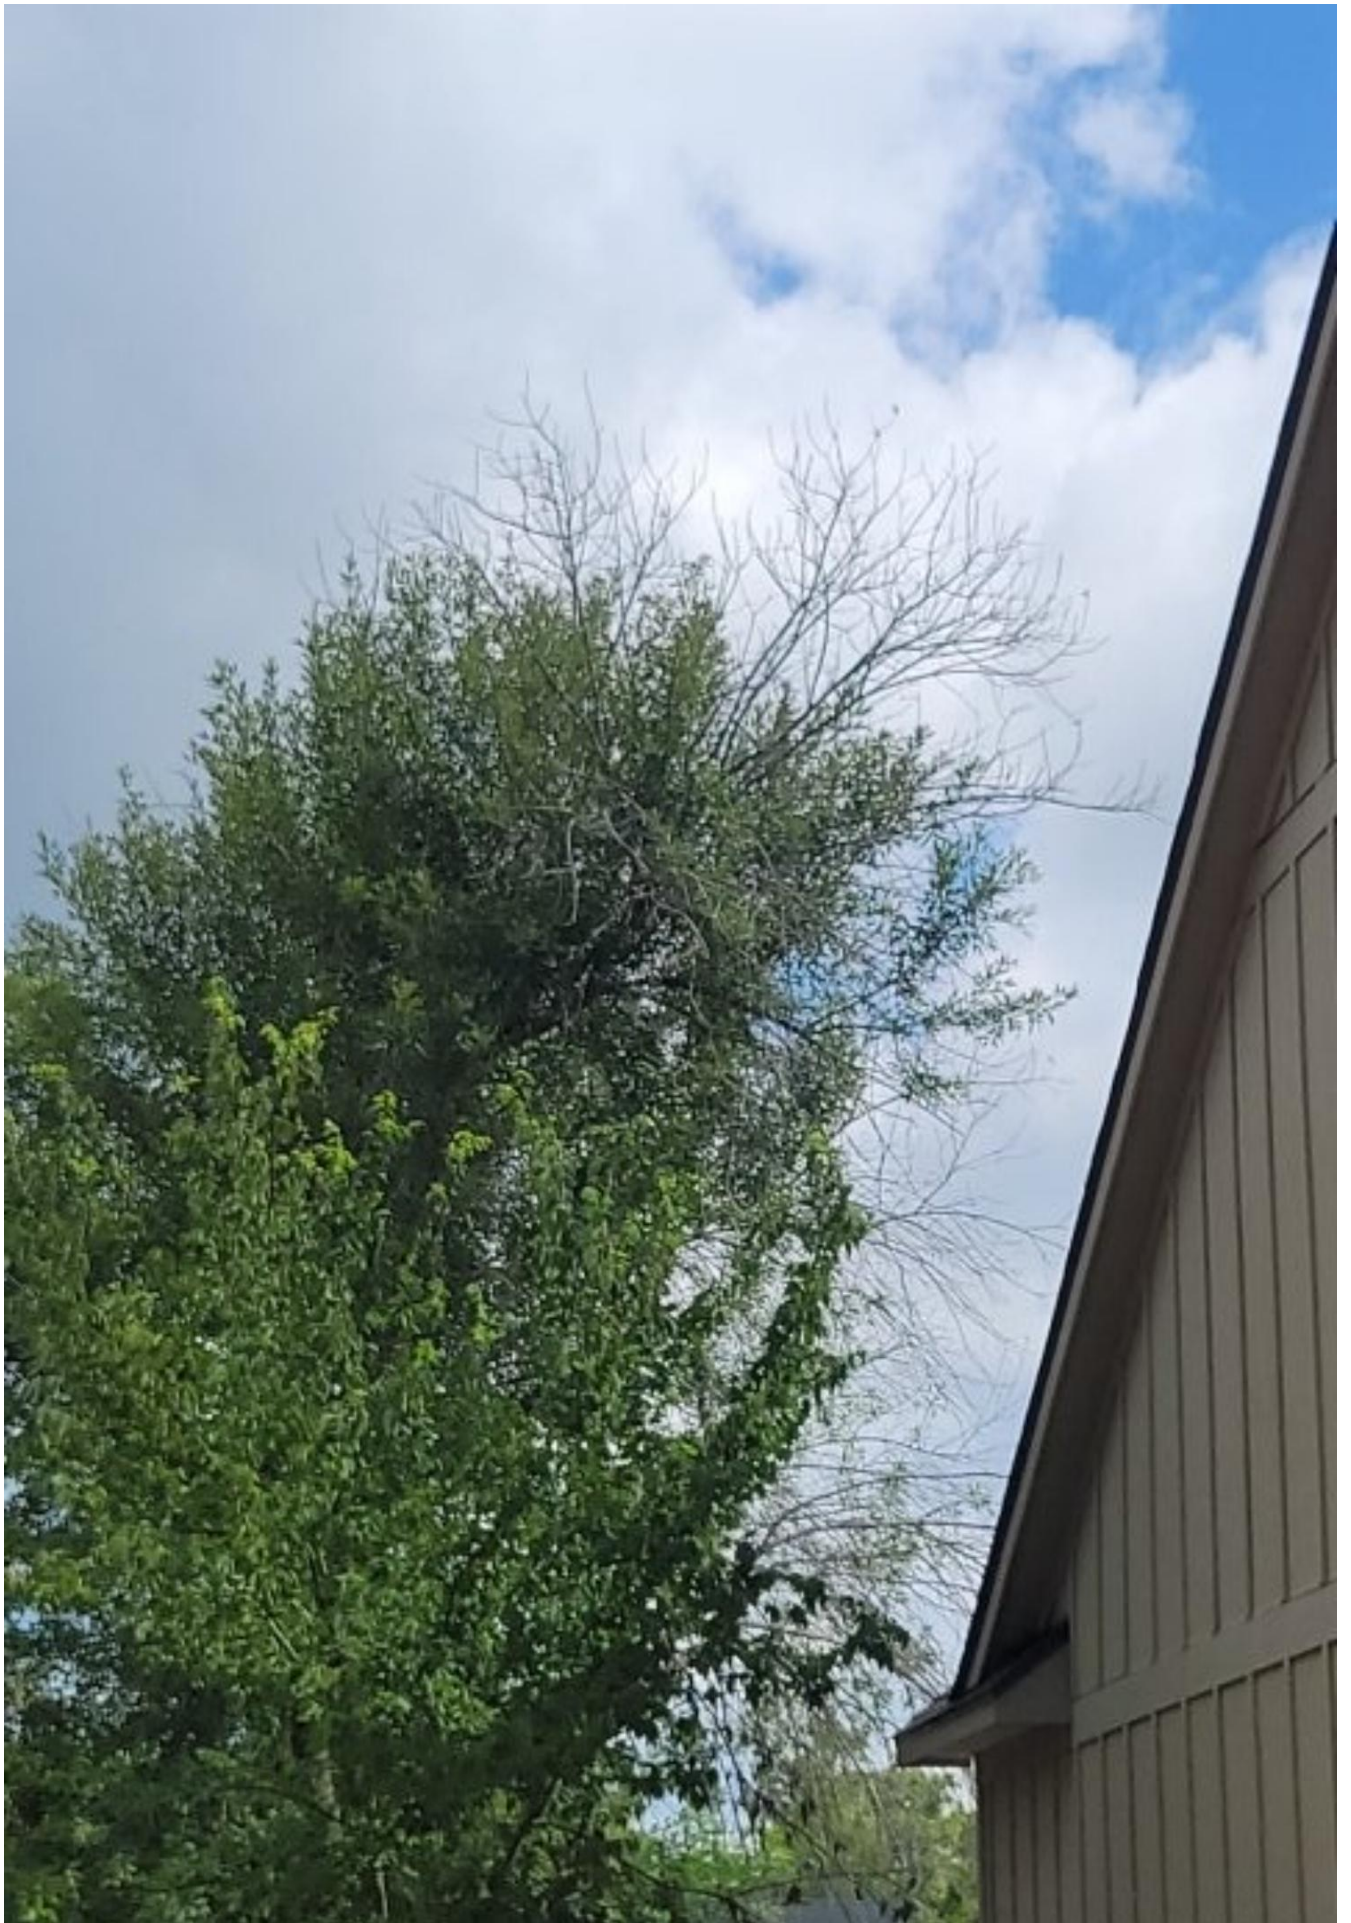
## 3.1.1 - Roof Covering

### Tree impending roof

At the time of inspection the inspector observed tree limbs impending the roof. During high strong winds the limbs may break off and damage the roofing material. Recommend to have a professional tree trimming company to provide quotes and recommendations.

Tree Service

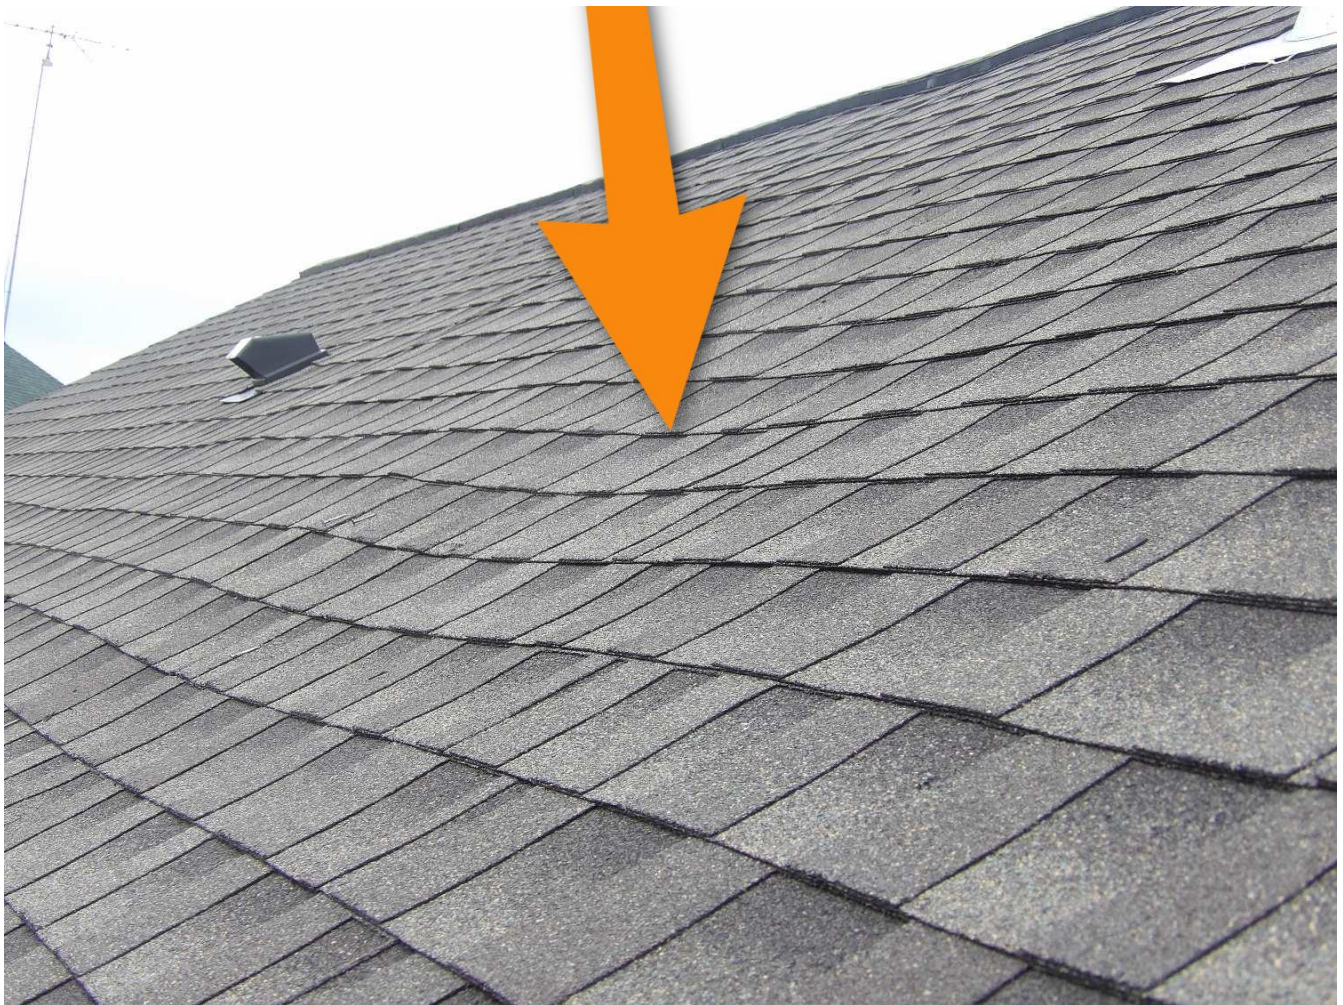
### 3.2.1 - Shingles Straight and Flat

### Wavy Shingles

The Shingles were wavy and not installed straight. We recommend to inspect and repair.

Builder

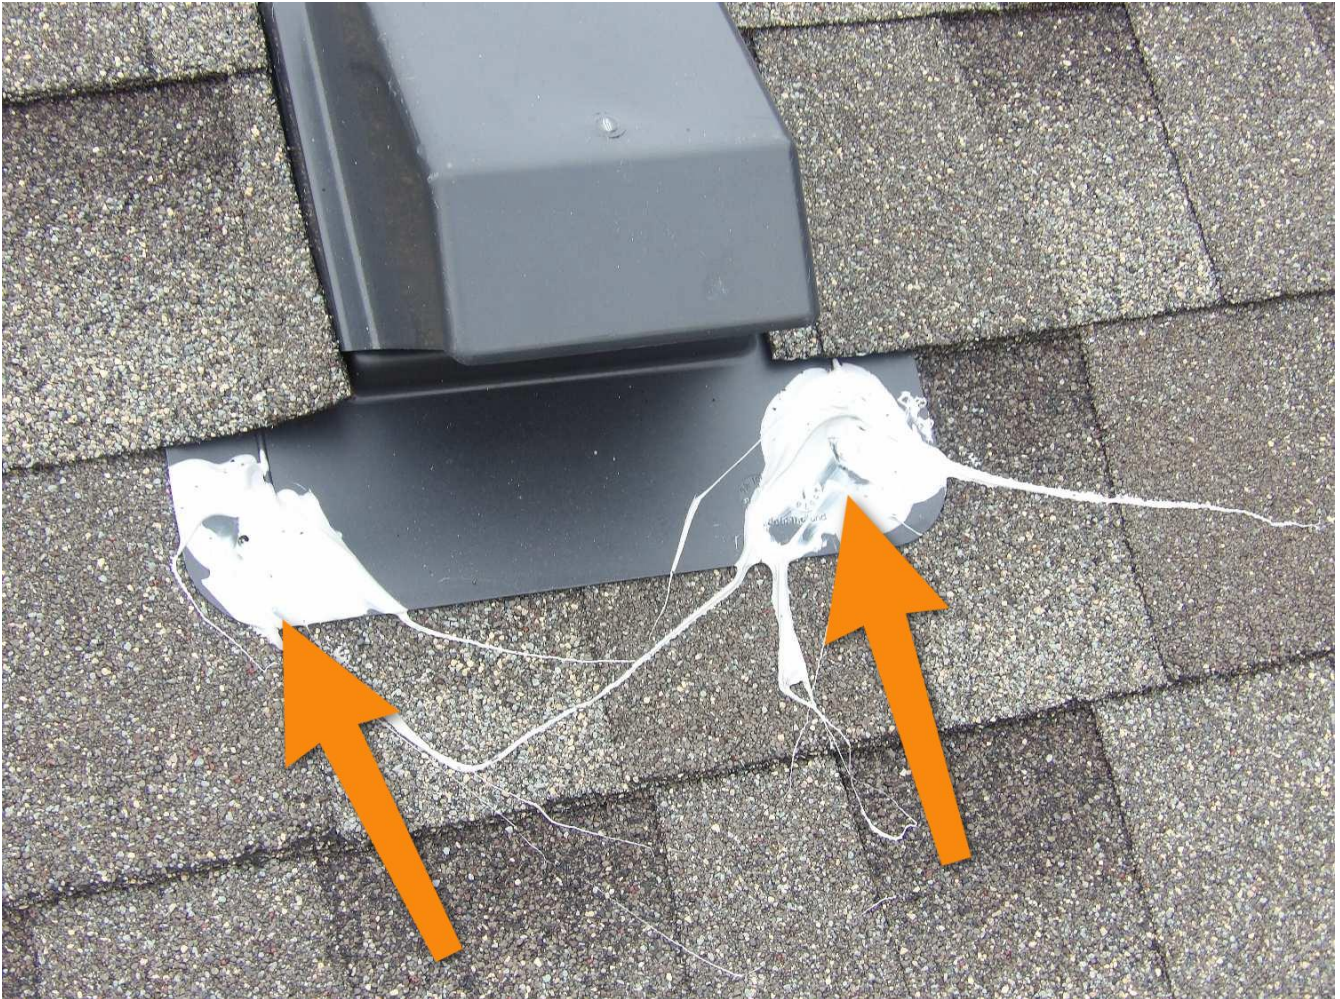
### 3.4.1 - Roof, Chimney, Flashing Installed

#### Flashing Sealant Bad

At the time of the inspection, the Flashing was dependant upon sealant to help prevent moisture intrusion into the roof structure. Some separation and/or cracking of the installed sealant was visible at the time of the inspection, this will increase the potential for moisture intrusion. We recommend to inspect and repair.

Builder

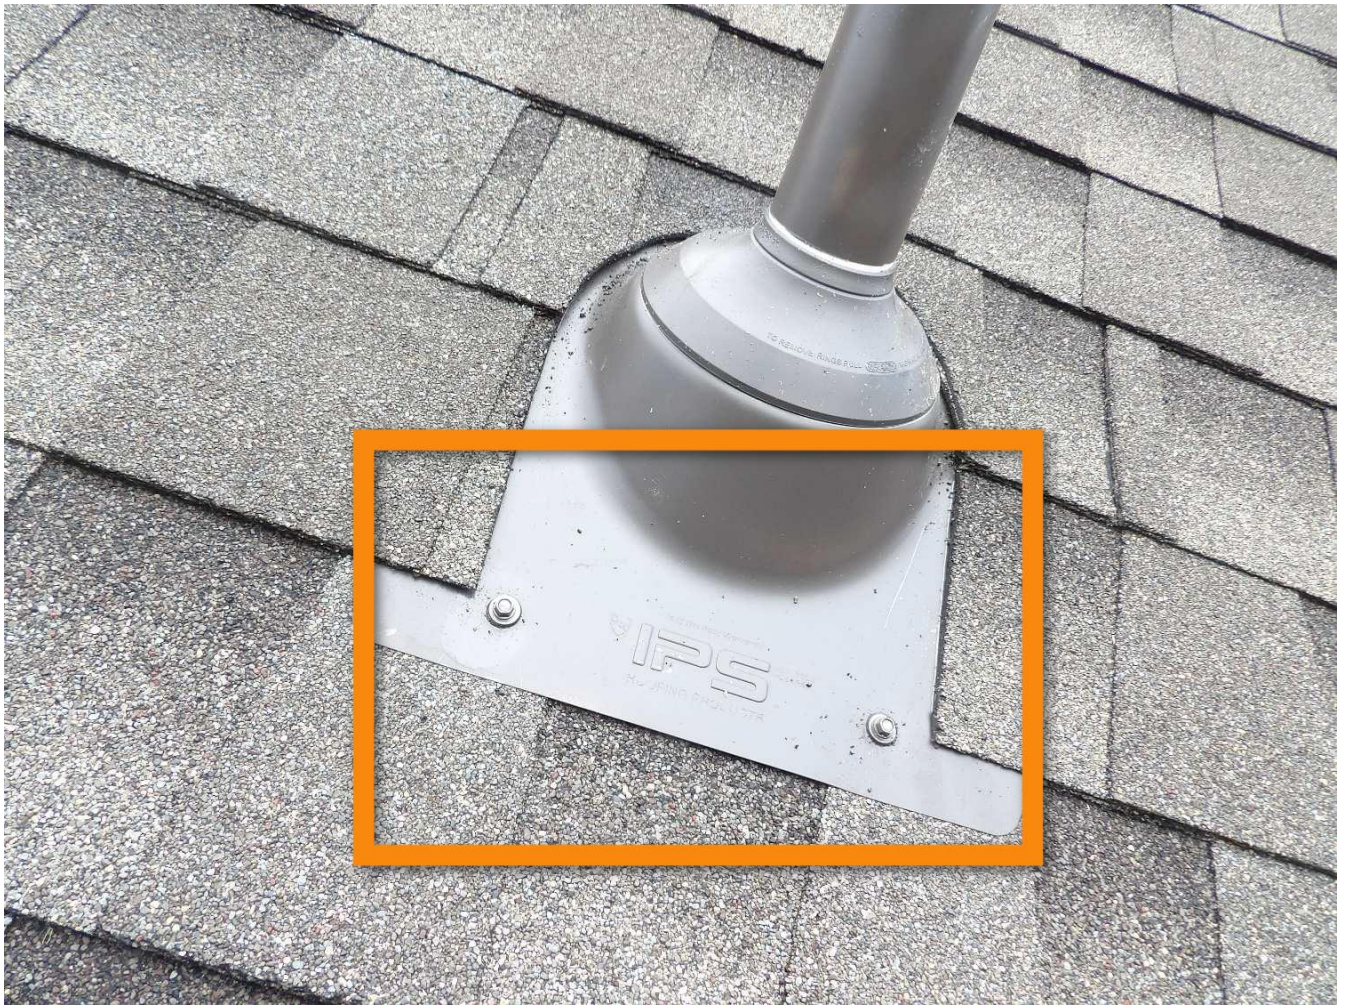
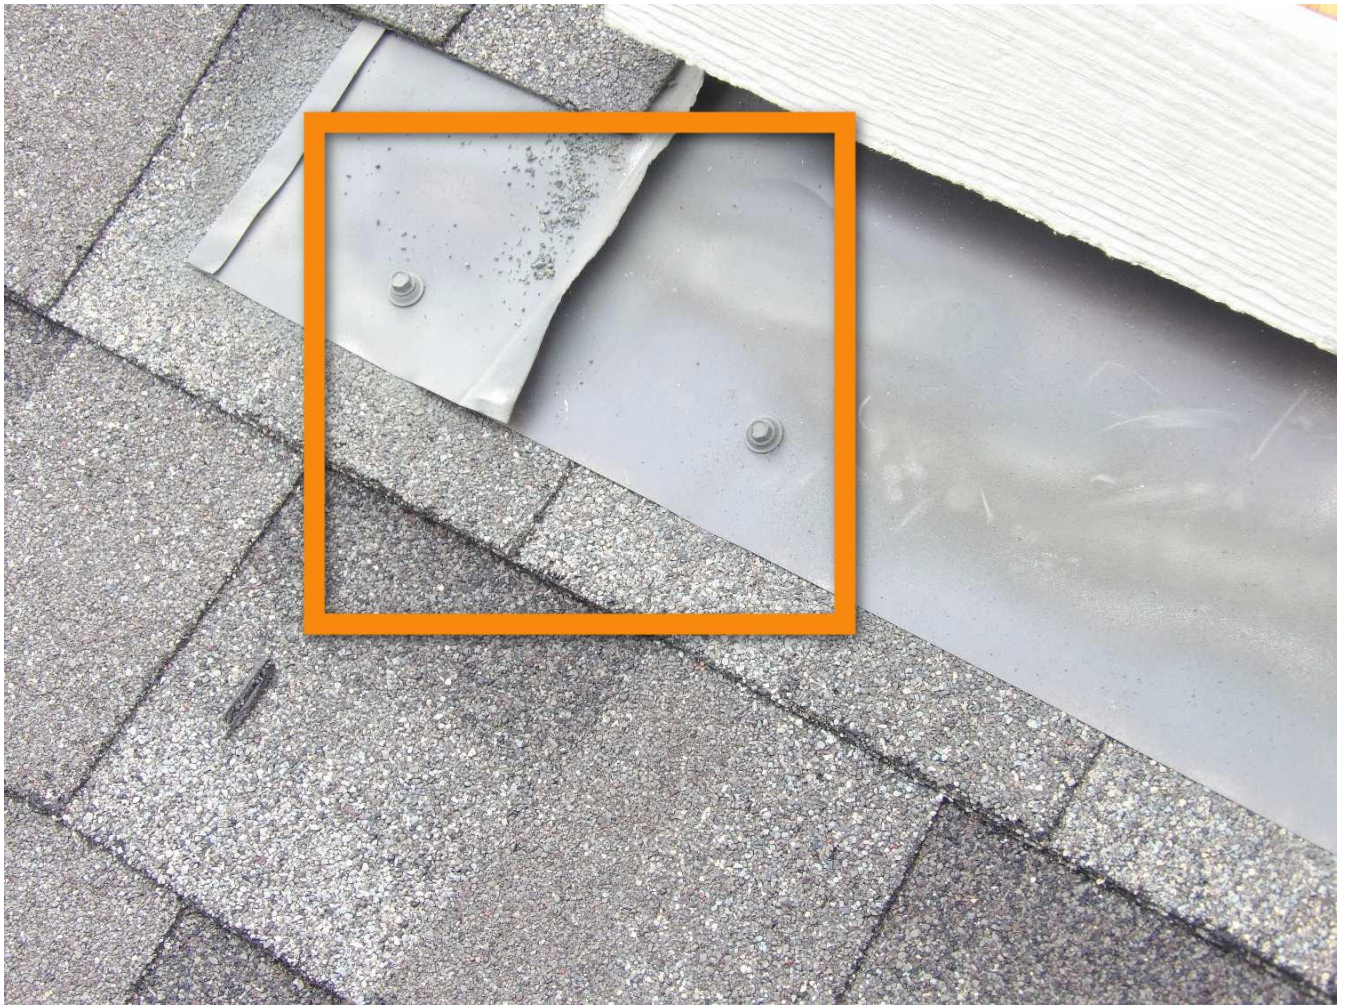
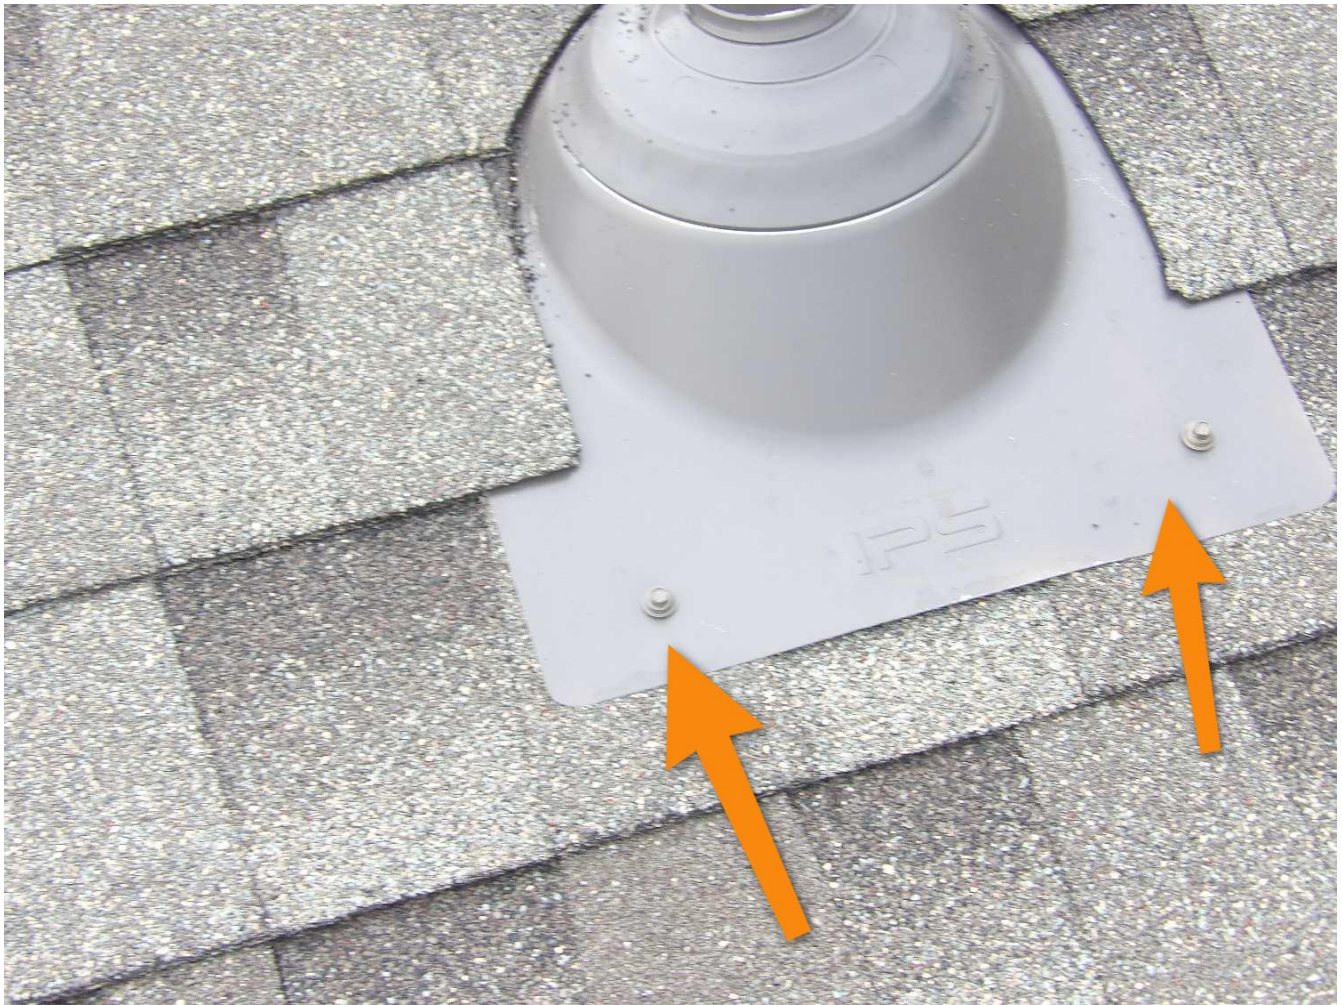
### 3.4.2 - Roof, Chimney, Flashing Installed

#### Improper fasteners on flashing

At the time of inspection the inspector observed improper fastener on the flashing around roof boots and step flashing. Recommend to have a qualified roofing contractor for further evaluation.

Roofing Professional

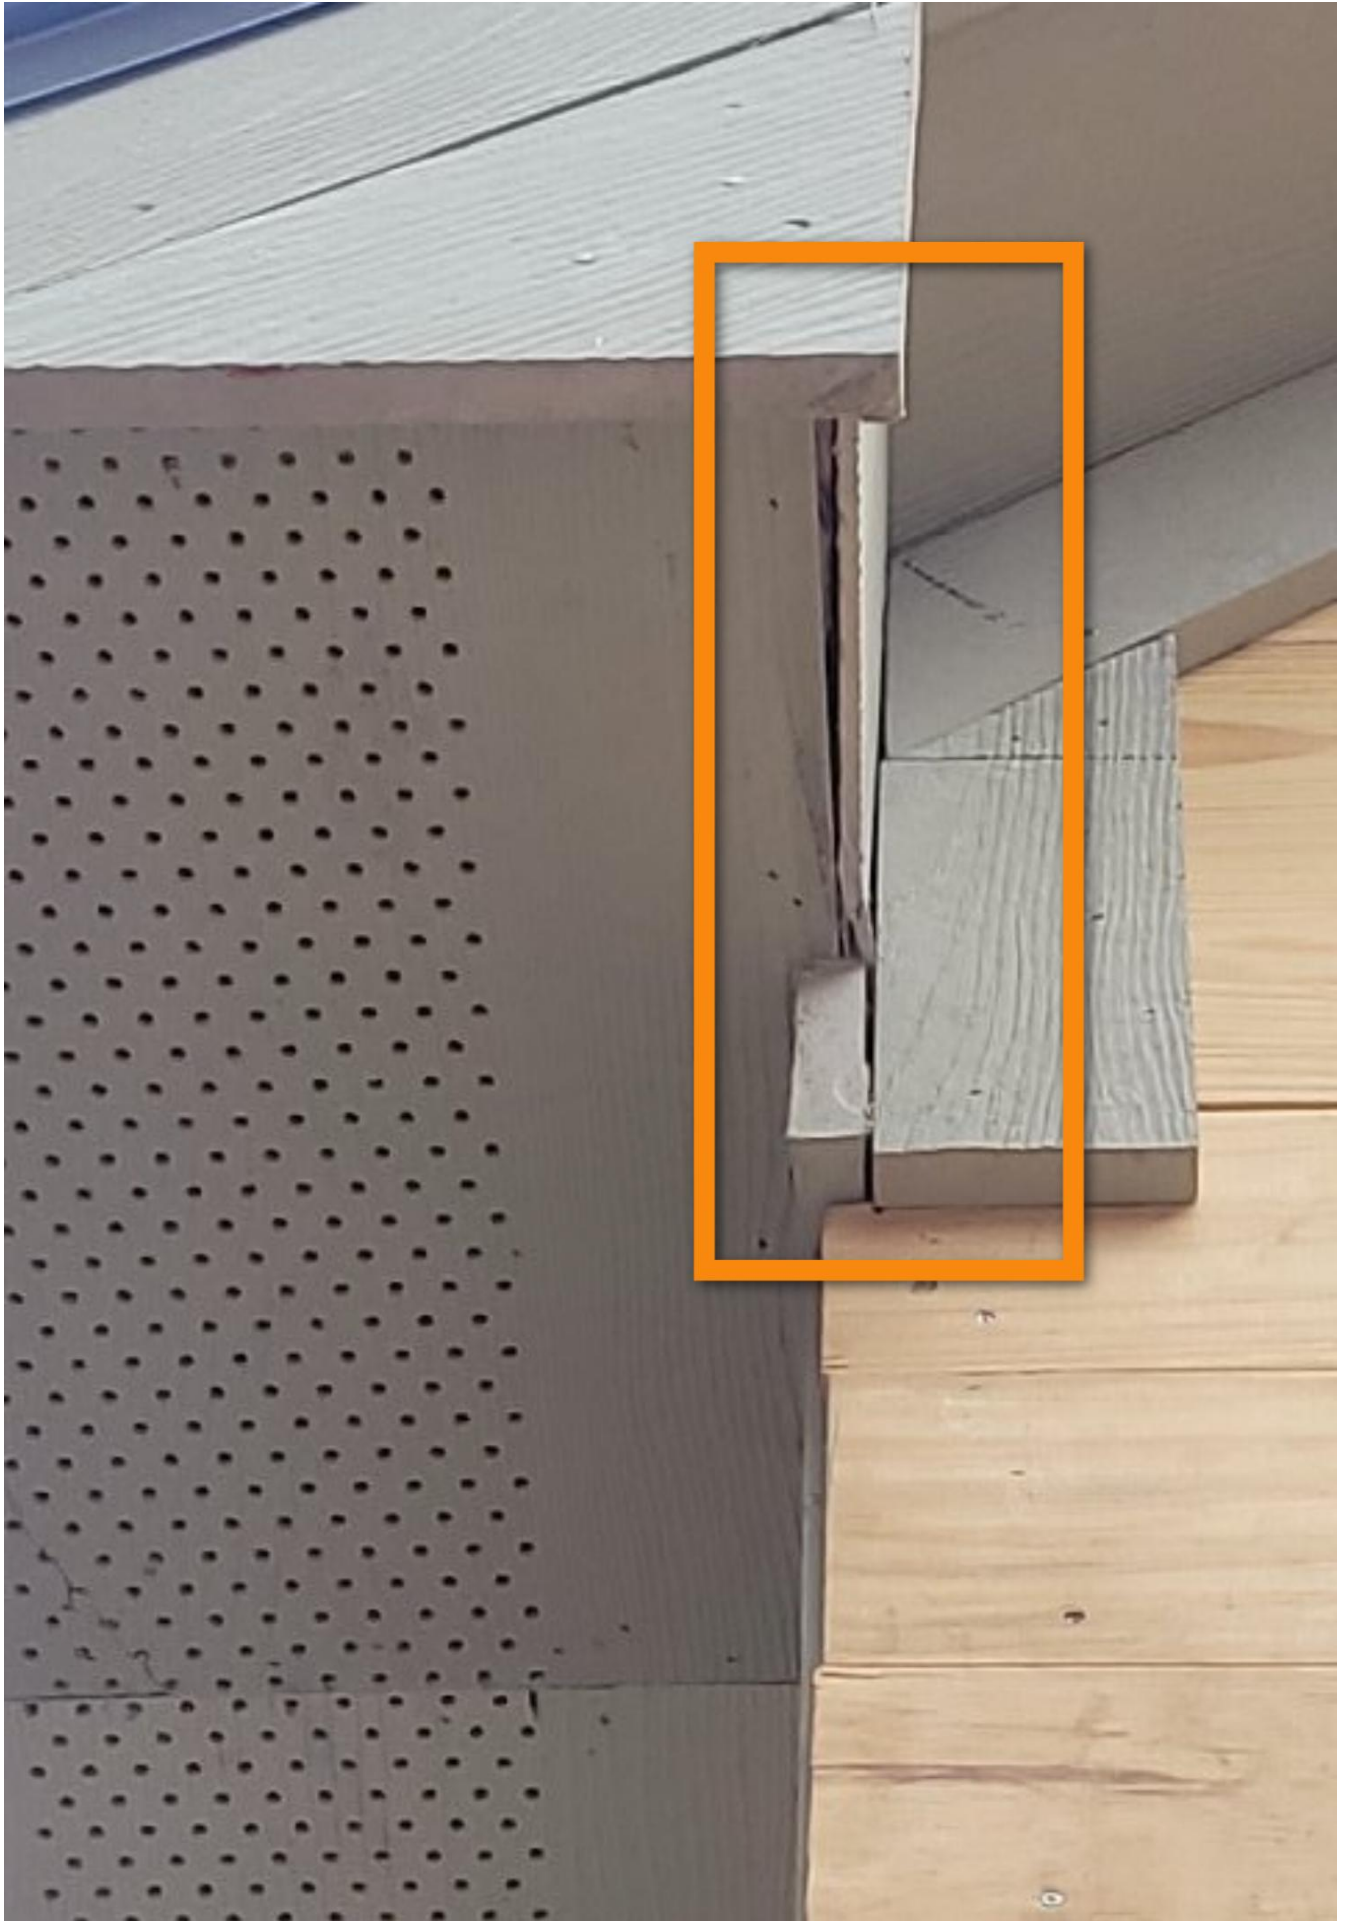
#### 4.3.1 - Fascia & Soffit

Damaged Soffit  
Soffit damage at the front left. corner.

Builder

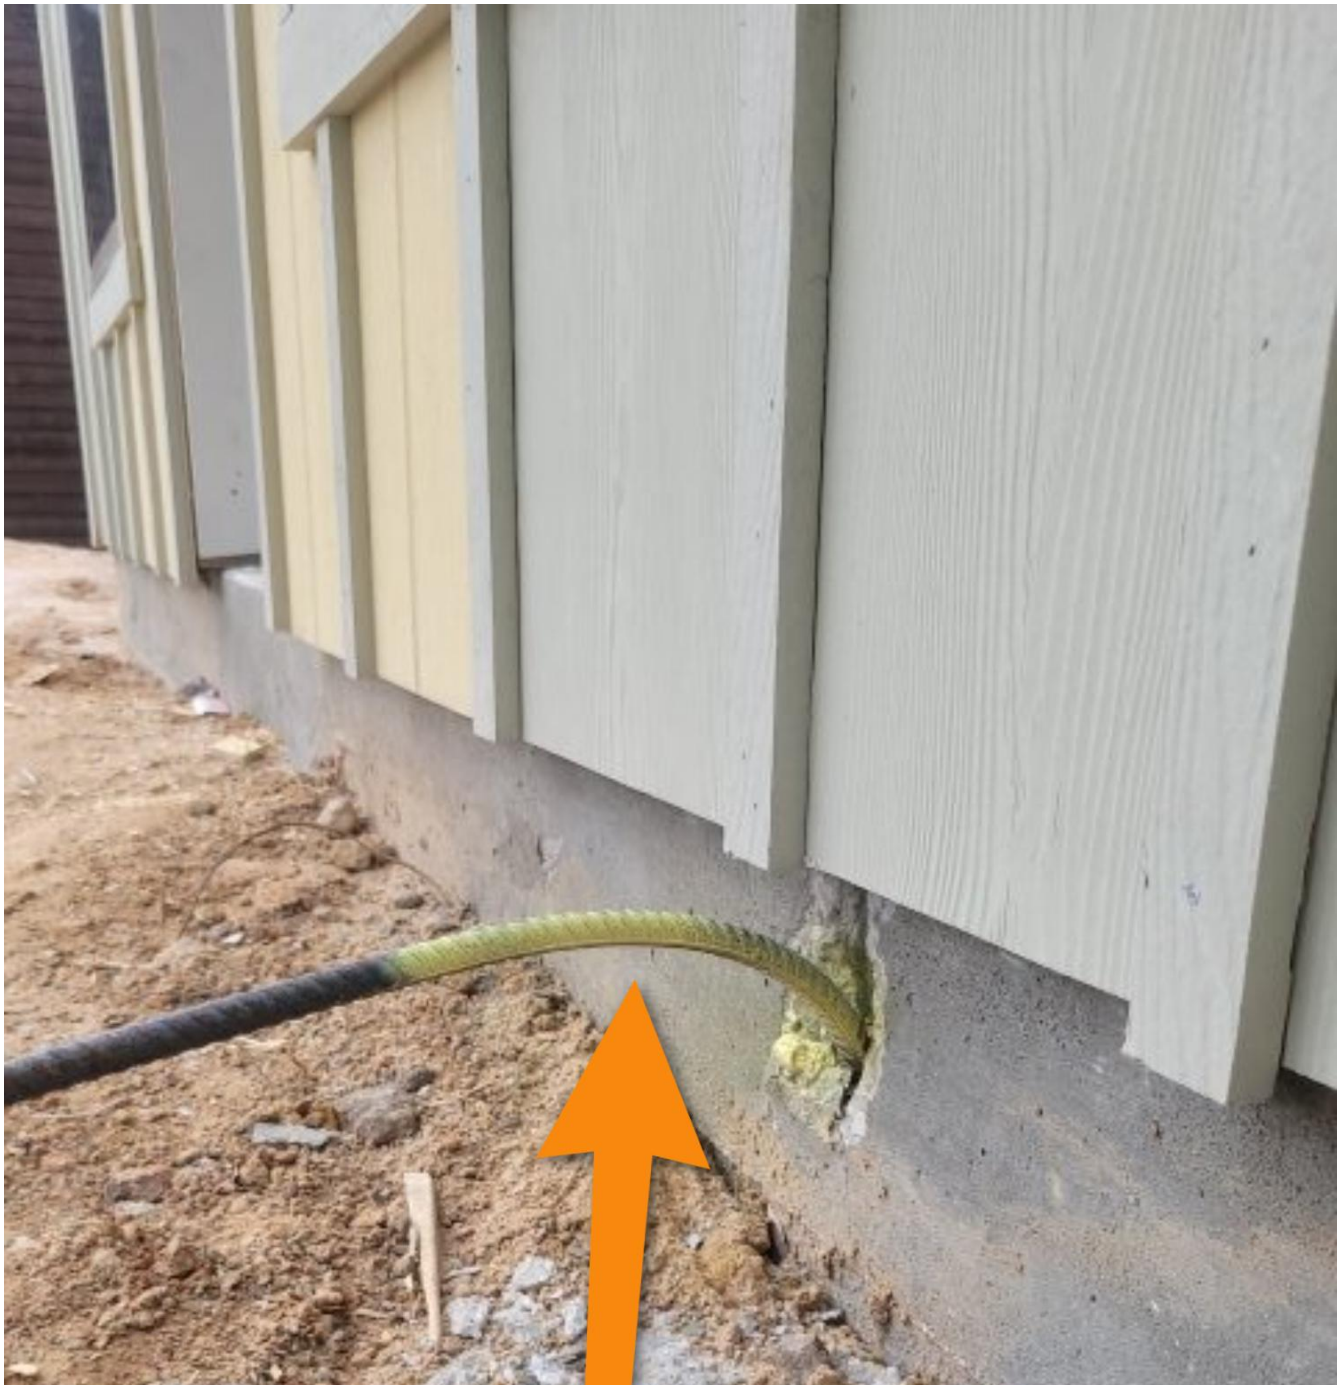
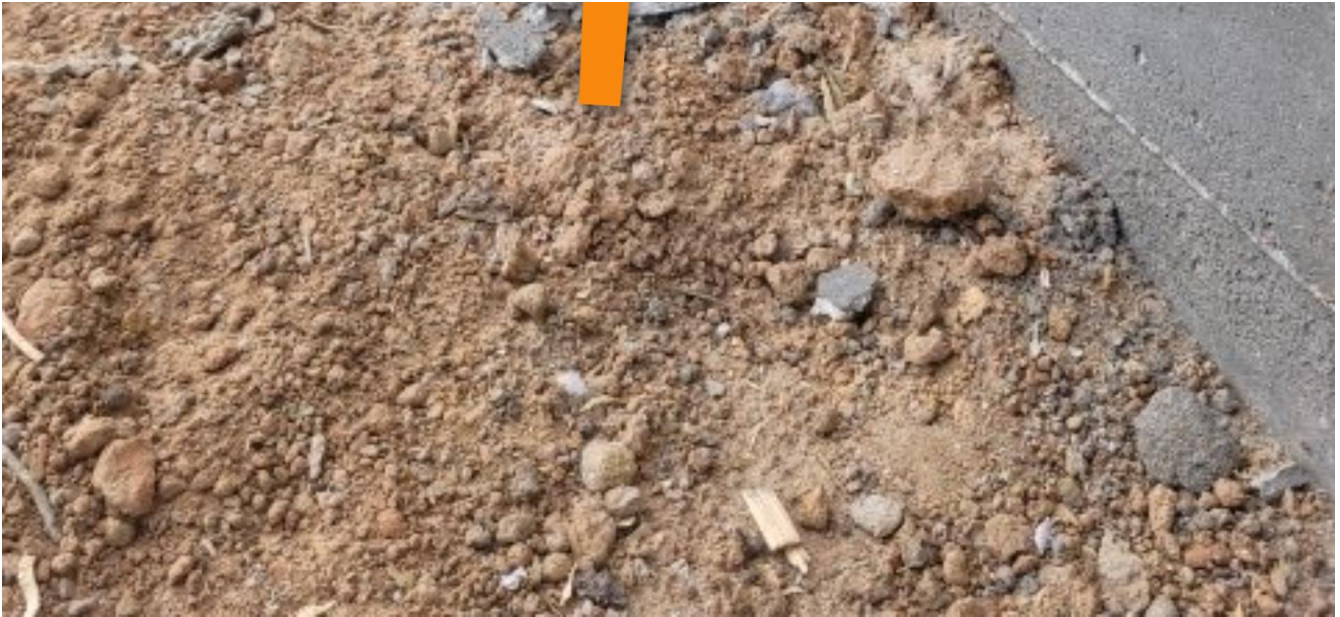
4.7.1 - Foundation

Exposed rebar  
Rebar exposed at rear of the home.

Builder

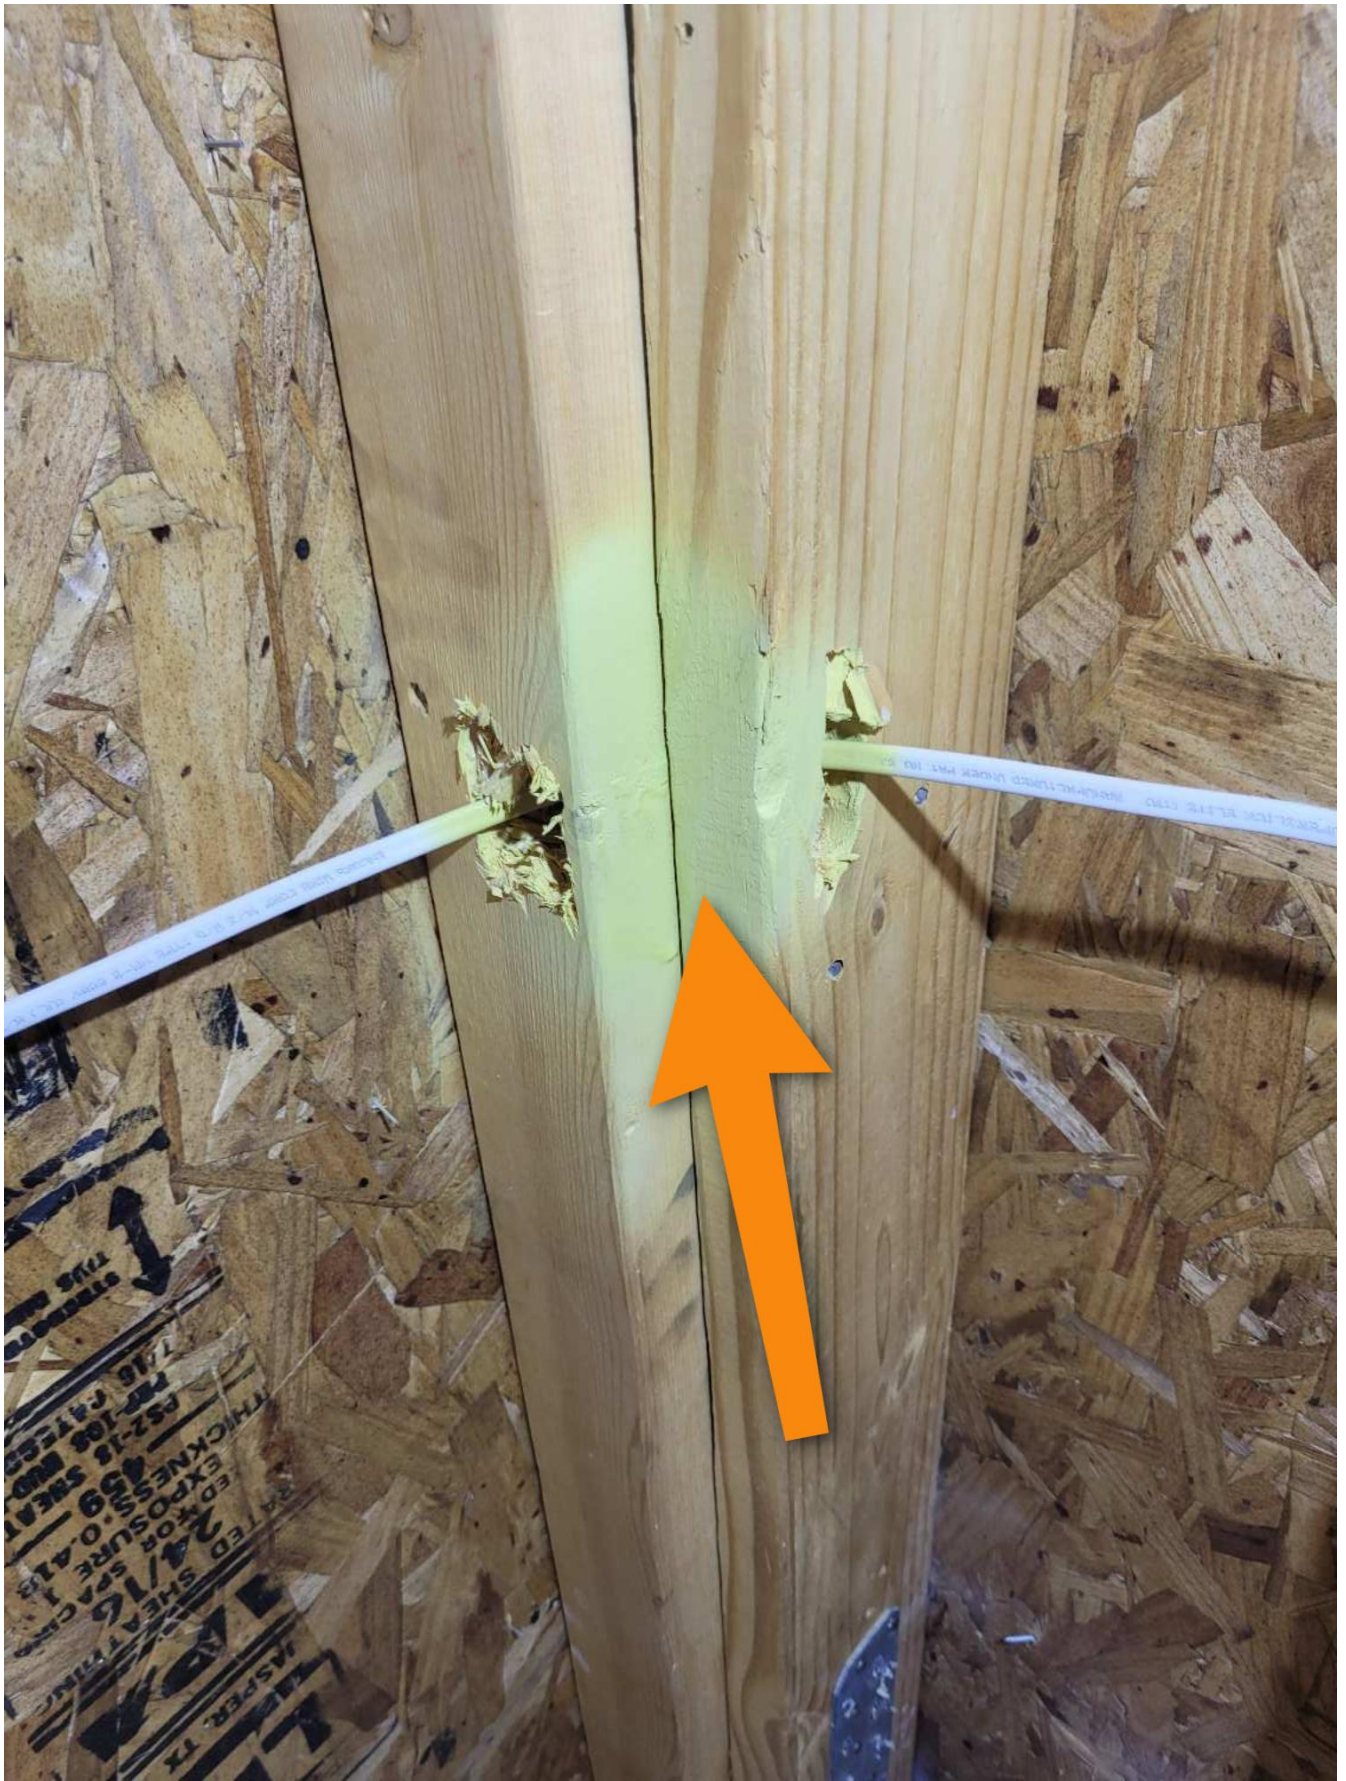
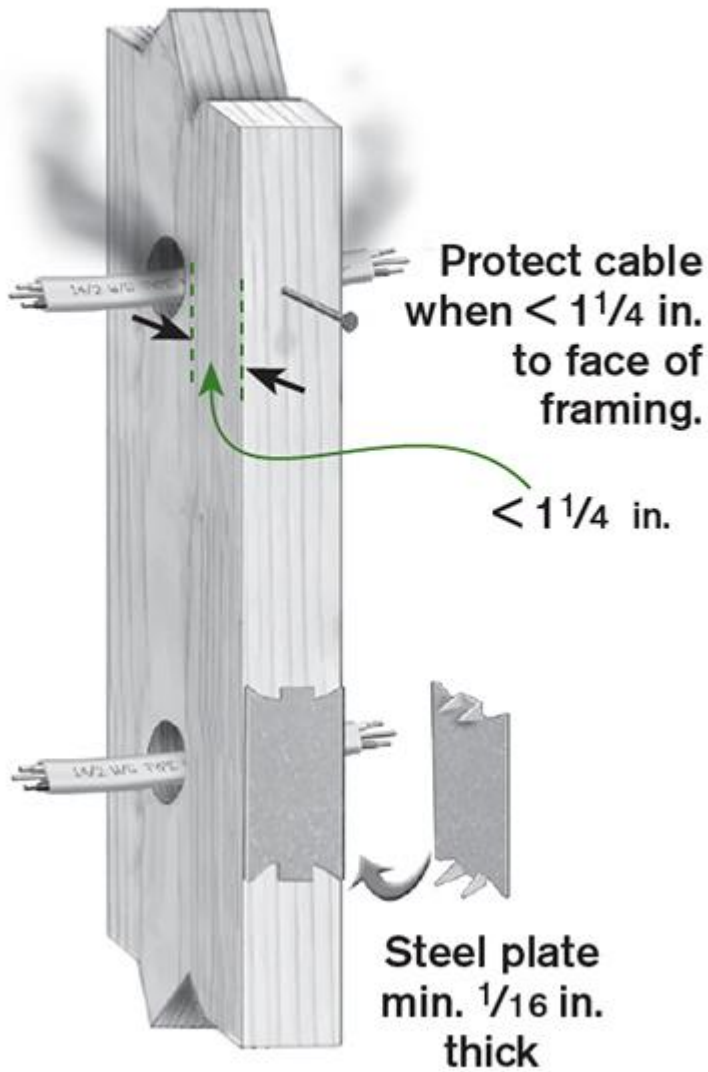
#### 5.12.1 - Strike Plates Properly Secured

Strike/Nail Plate protection

Electrical Contractor

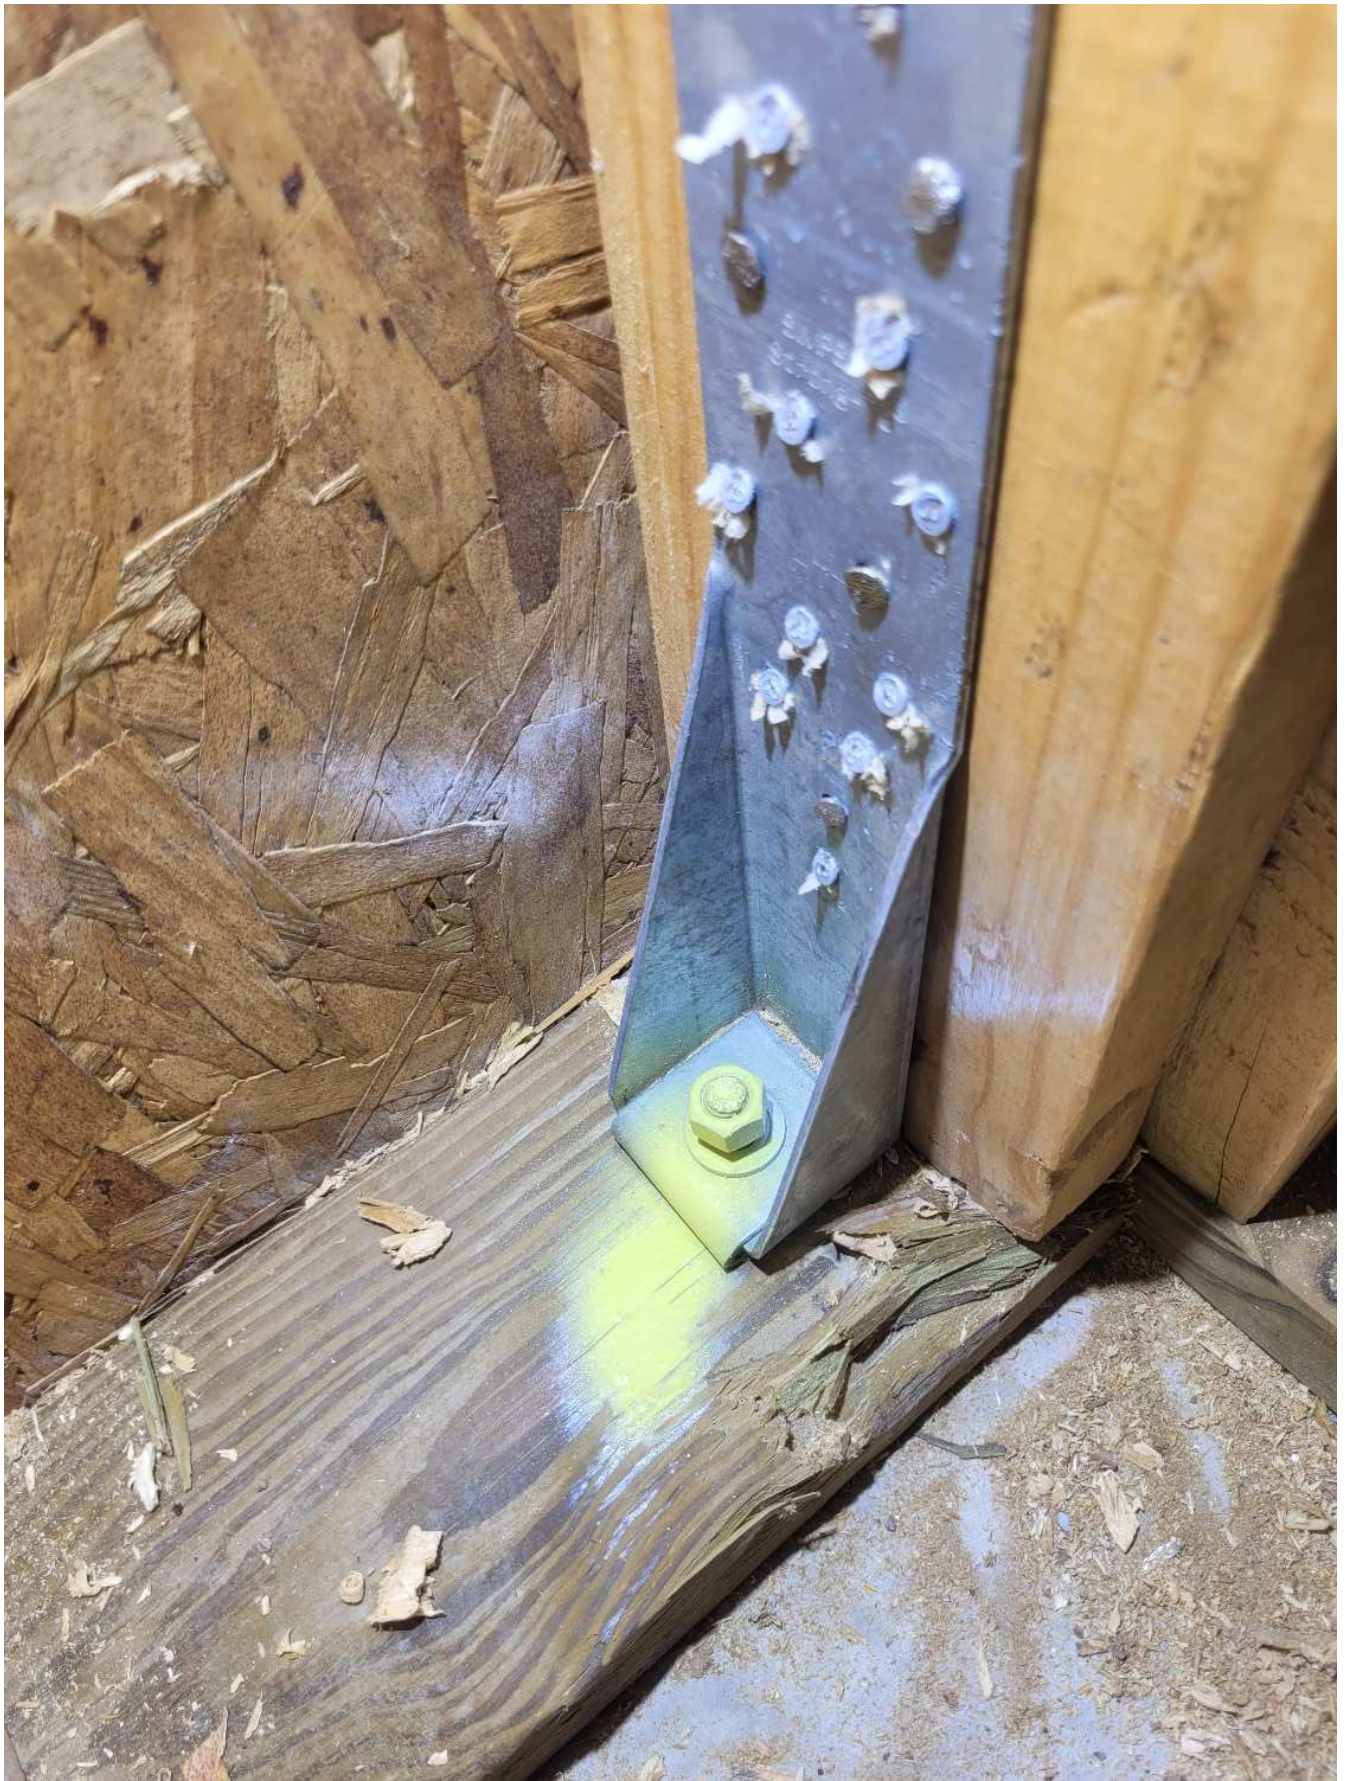
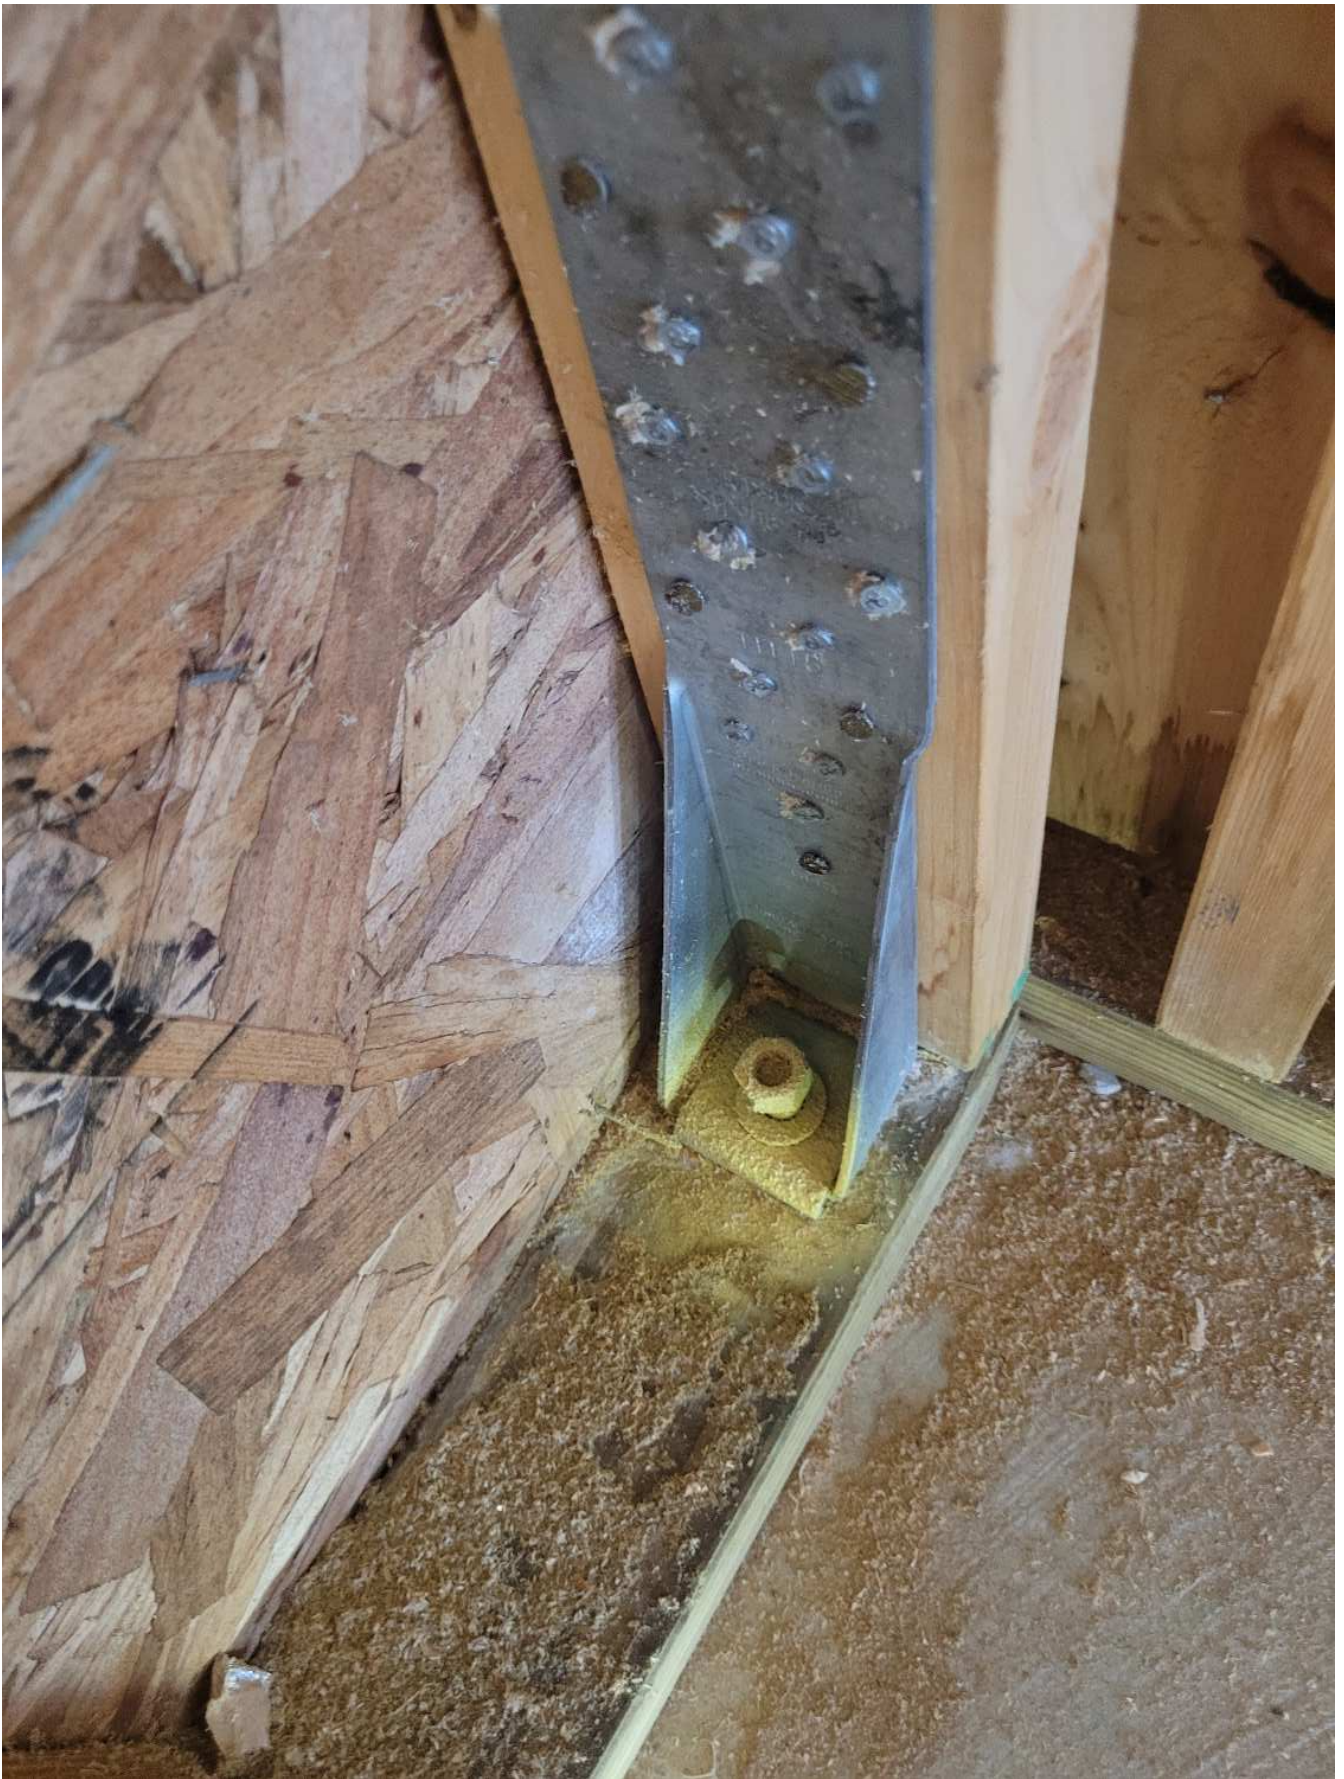
5.14.1 - Proper Stud Spacing, Anchor bolt nuts

Anchor bolts

Qualified Professional
