# HOME INSPECTION SERVICES INC.

10 Hunters Creek Dr  
Huntsville, TX 77340  
08/26/2022 9:30 am

Inspector  
Raymond Bennett  
TREC#24071

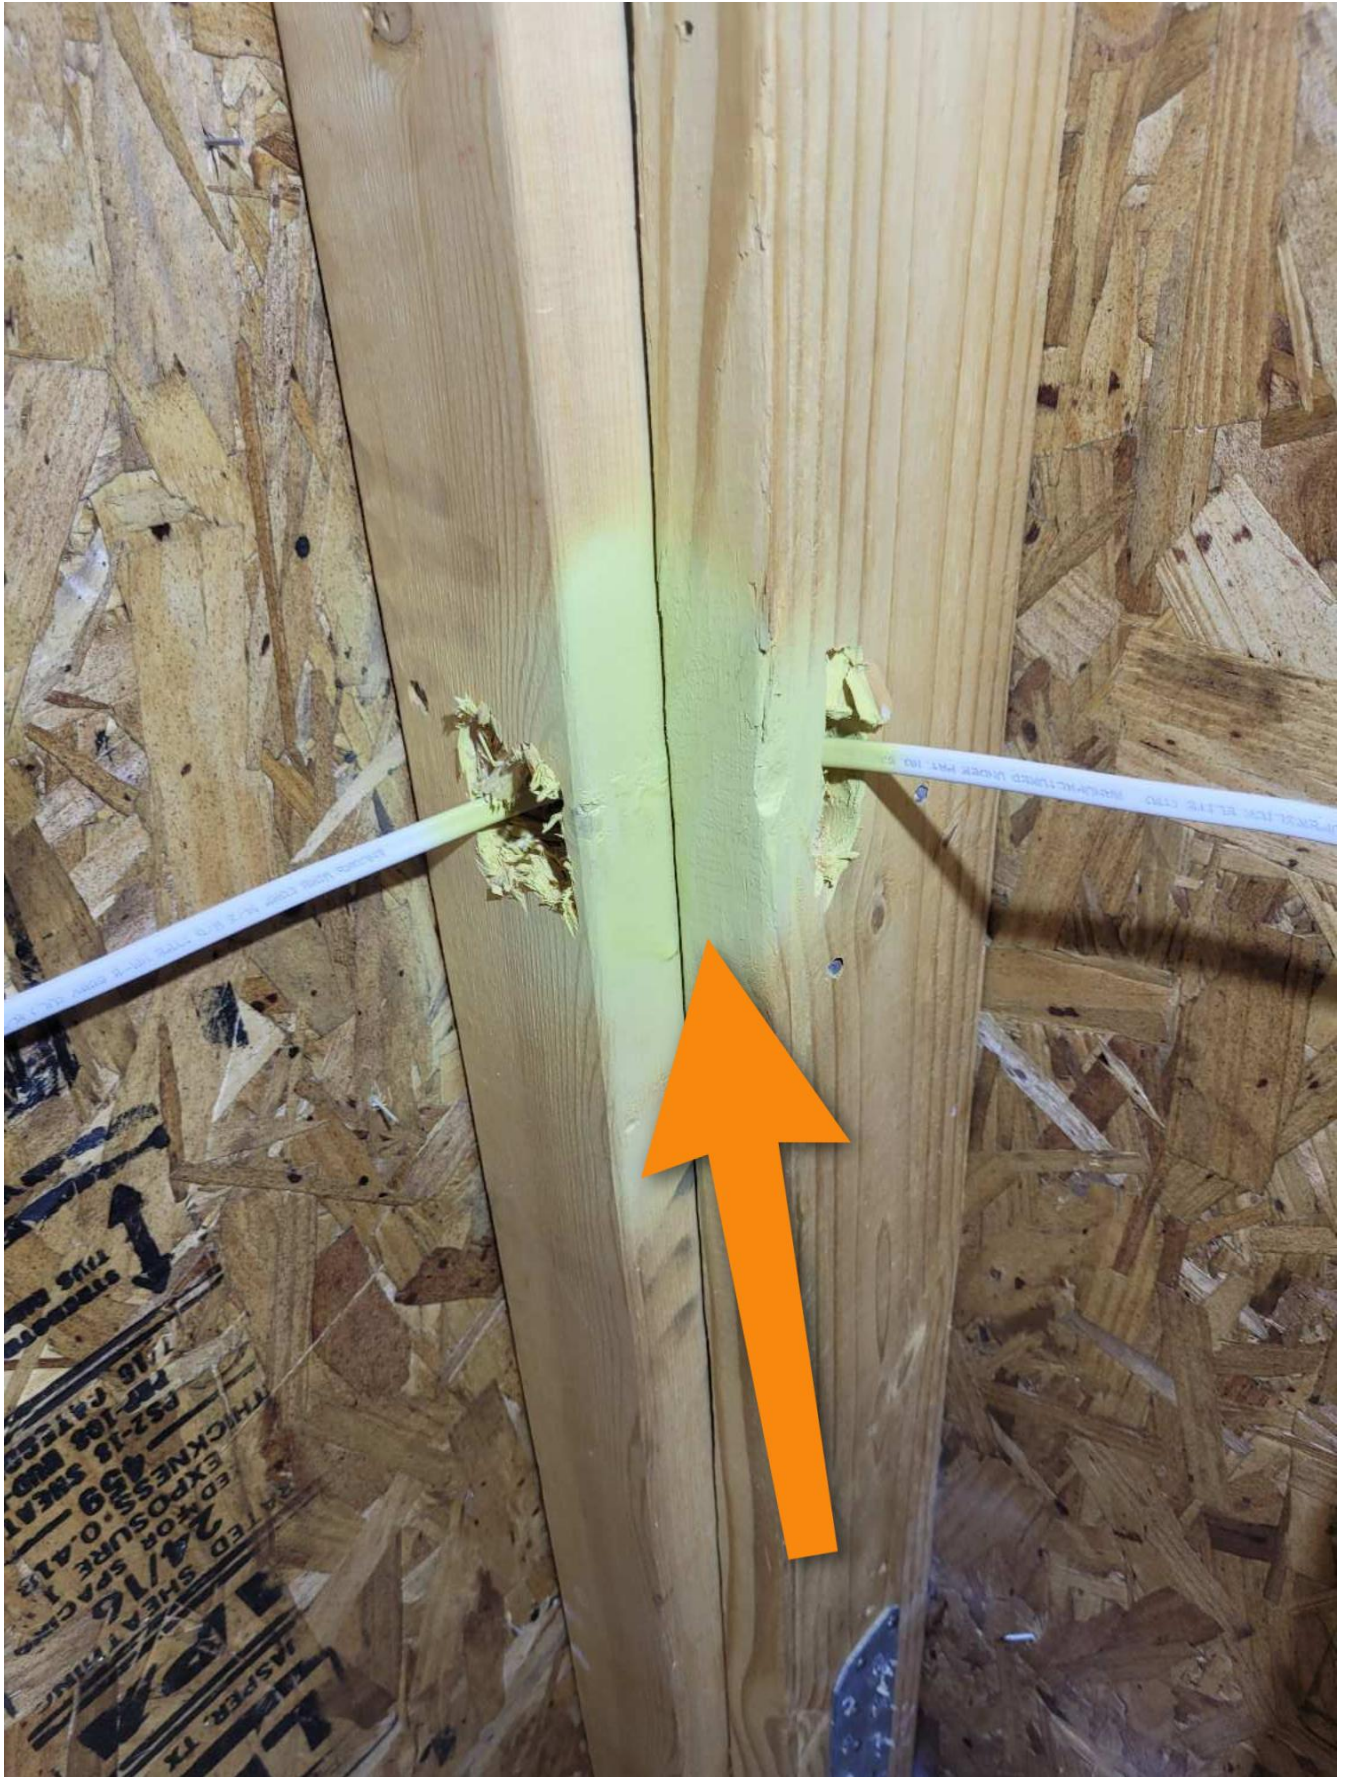
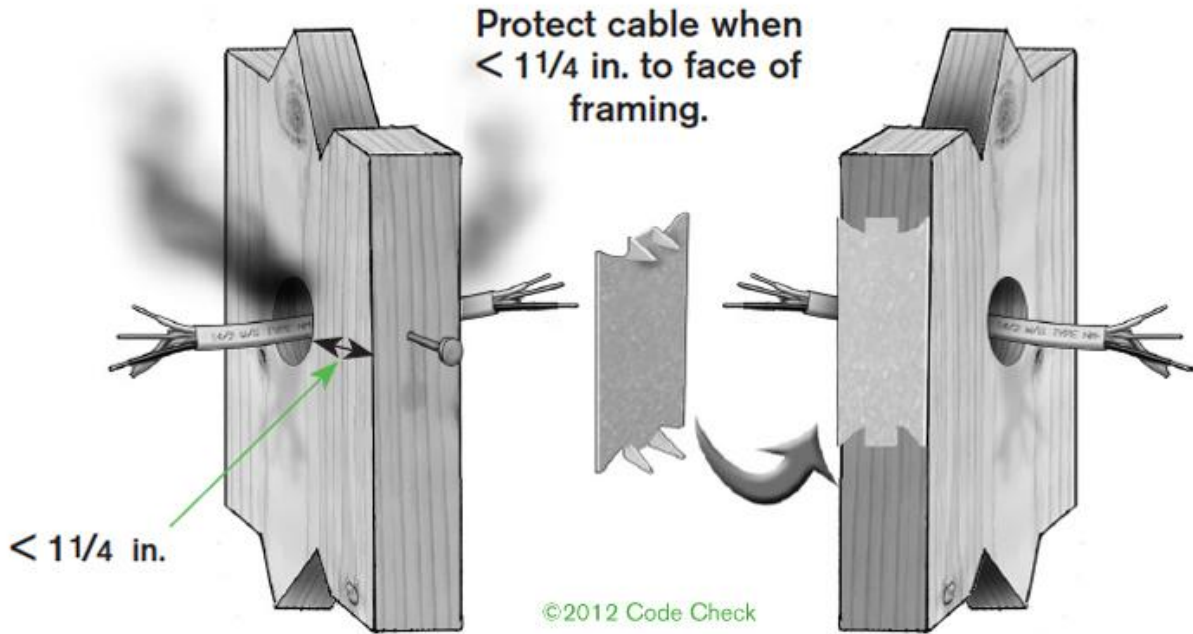
#### **7.4.1 - Nail Guards Present & Properly Installed**

### Missing Nail Guards

Nail Guards were missing in various locations at the time of inspection. Provided a few reference photos. Builder should inspect entire home and install as per code requirements.

Builder

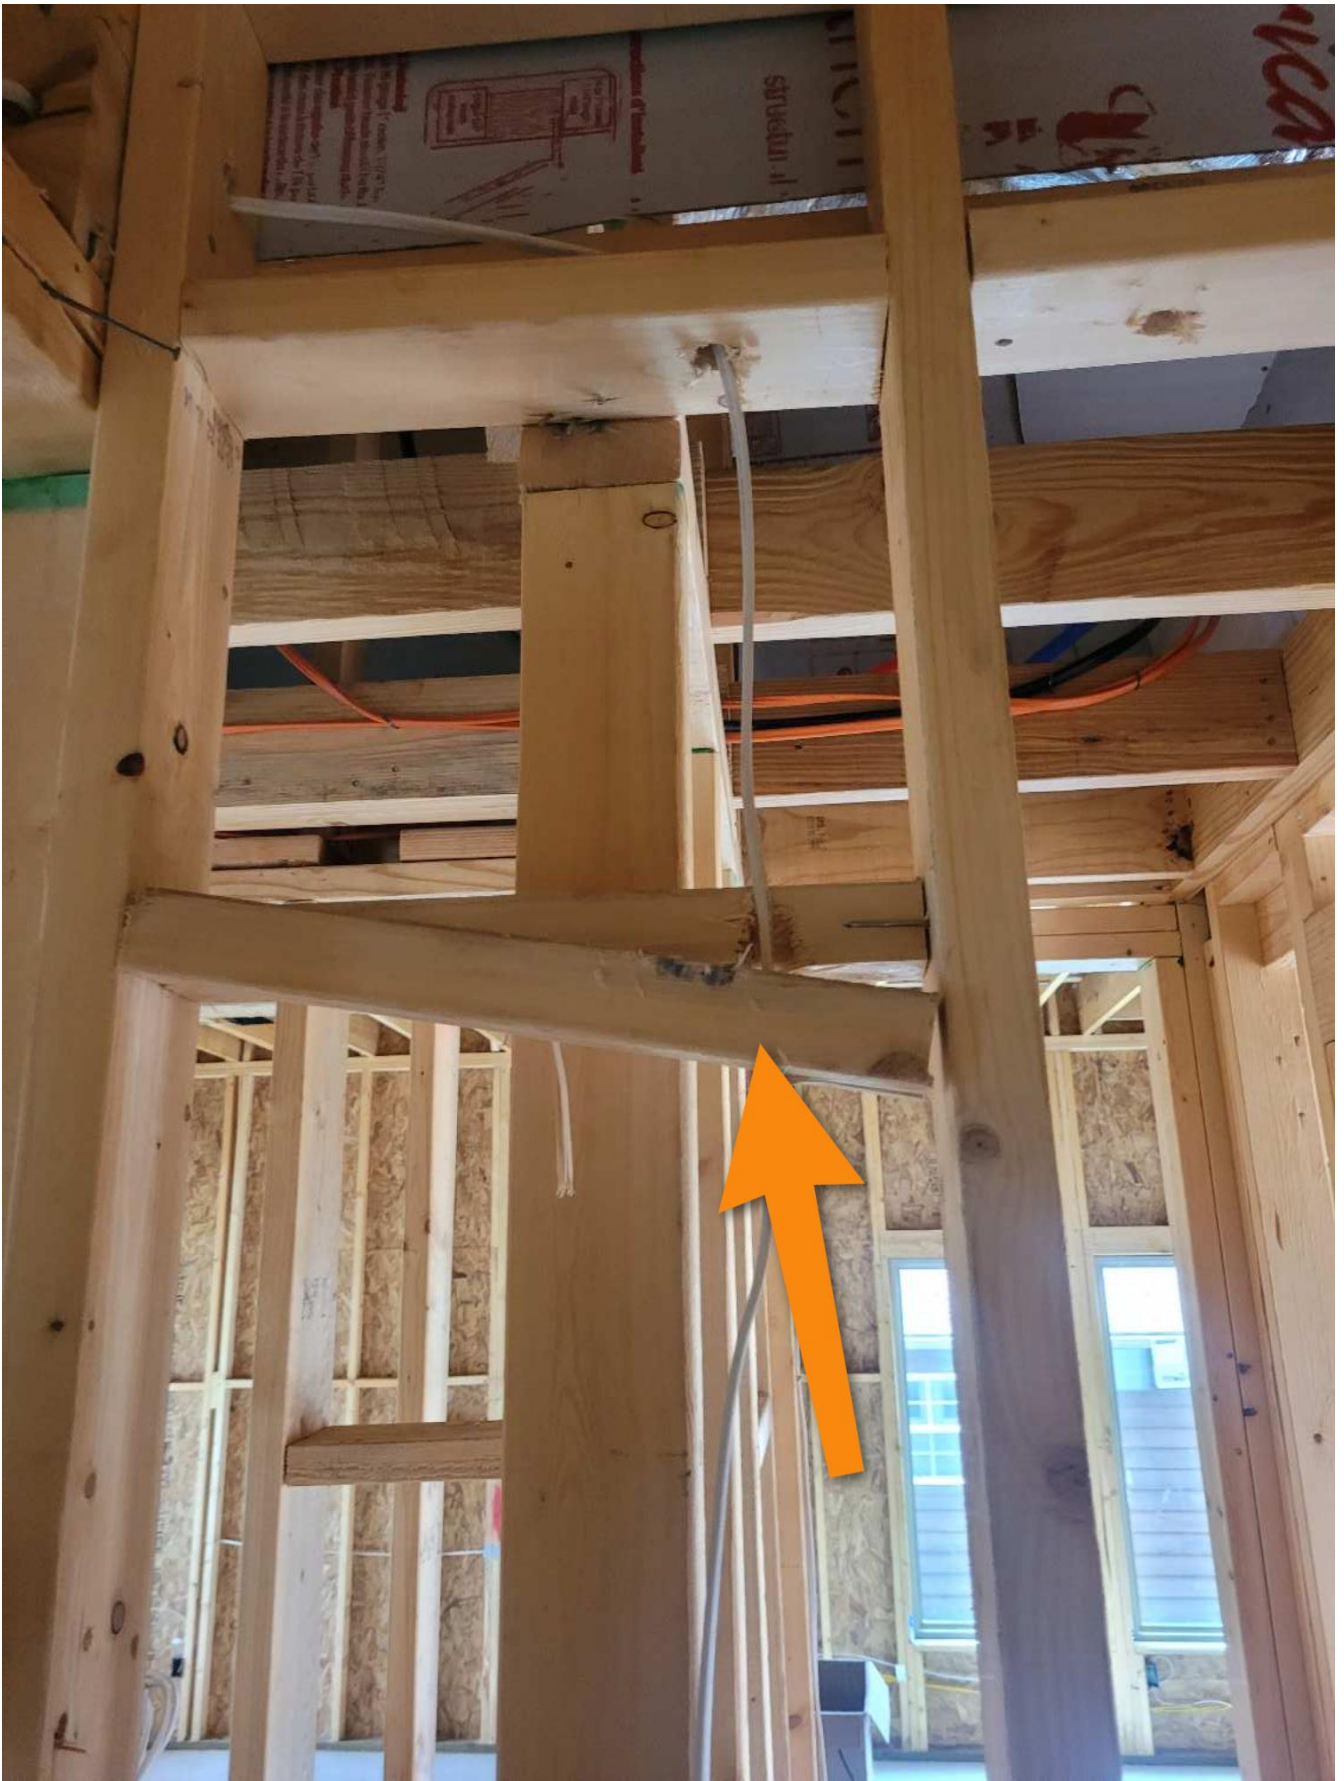
**11.2.1 - Walls & Columns Plumb/Bowed**

Damaged Blocking

Builder
