# HOME INSPECTION SERVICES INC.

10 Hunters Creek Dr  
Huntsville, TX 77340  
08/26/2022 9:30 am

Inspector  
Raymond Bennett  
TREC#24071

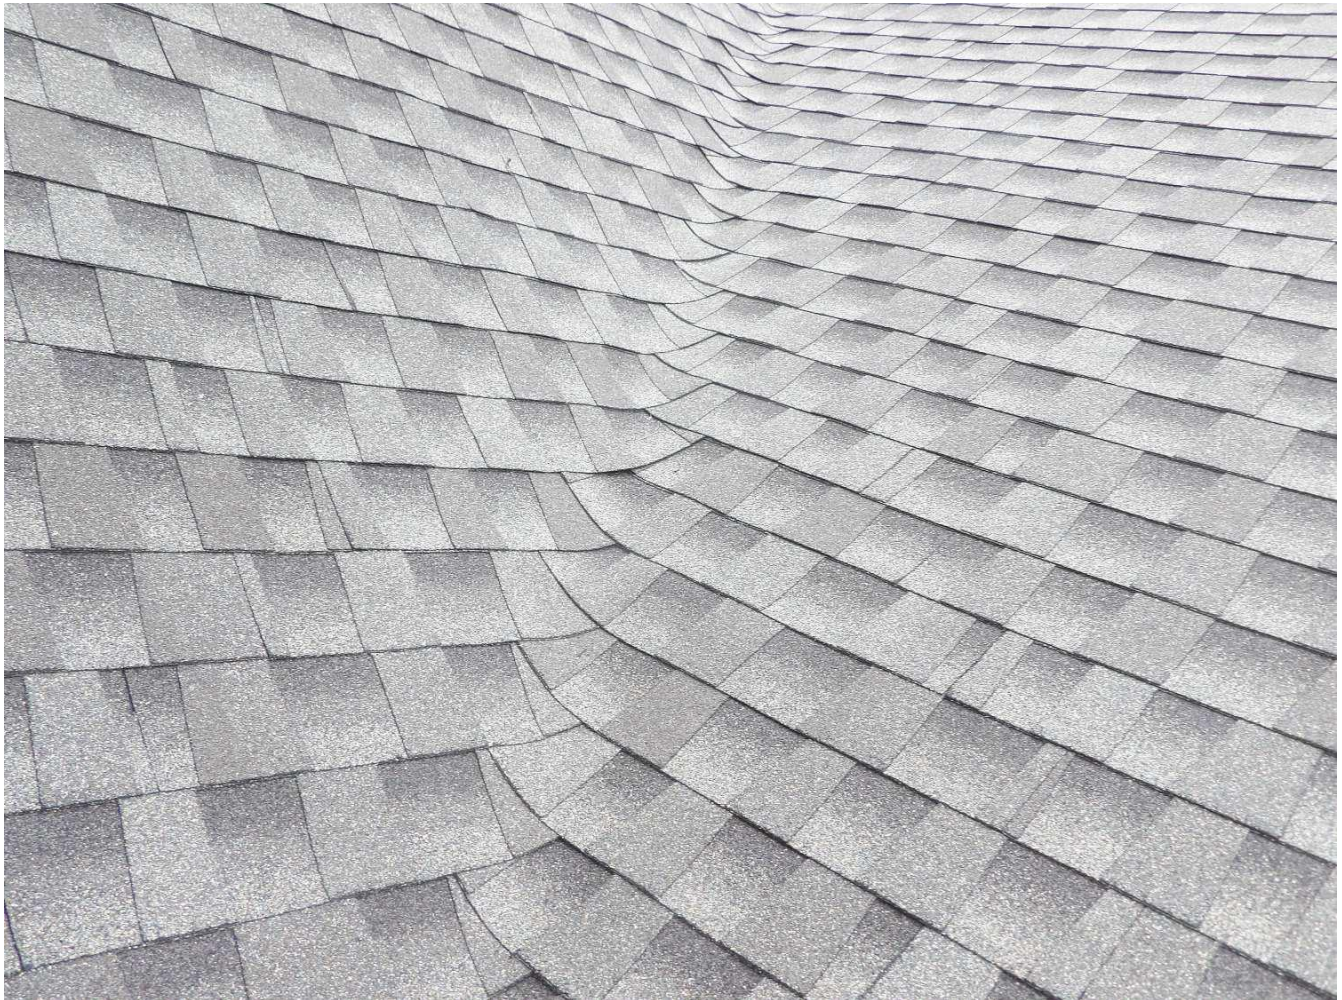
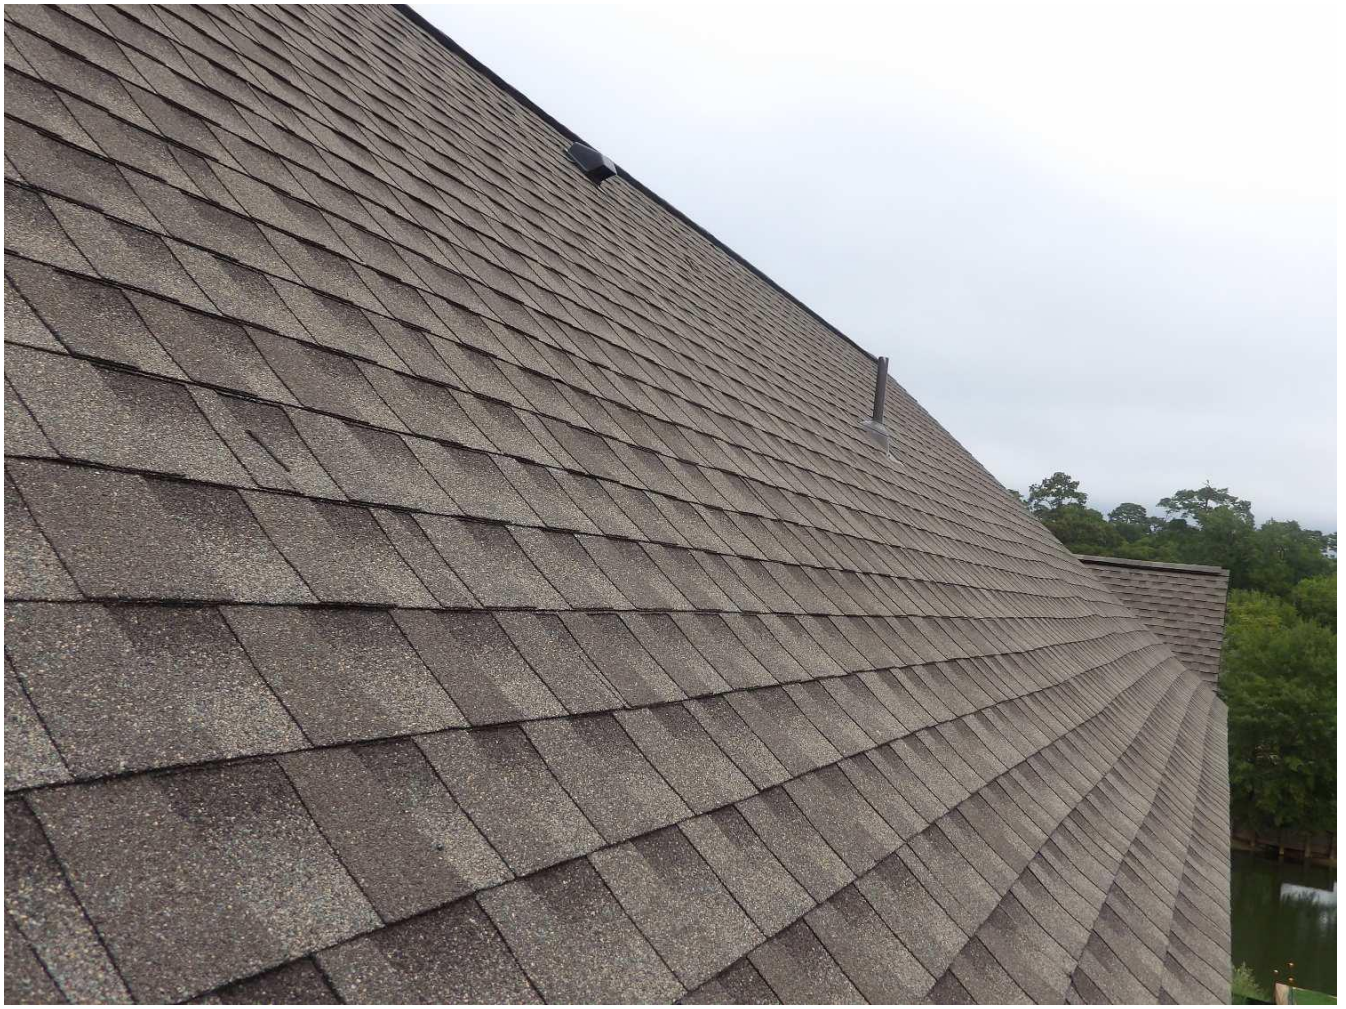
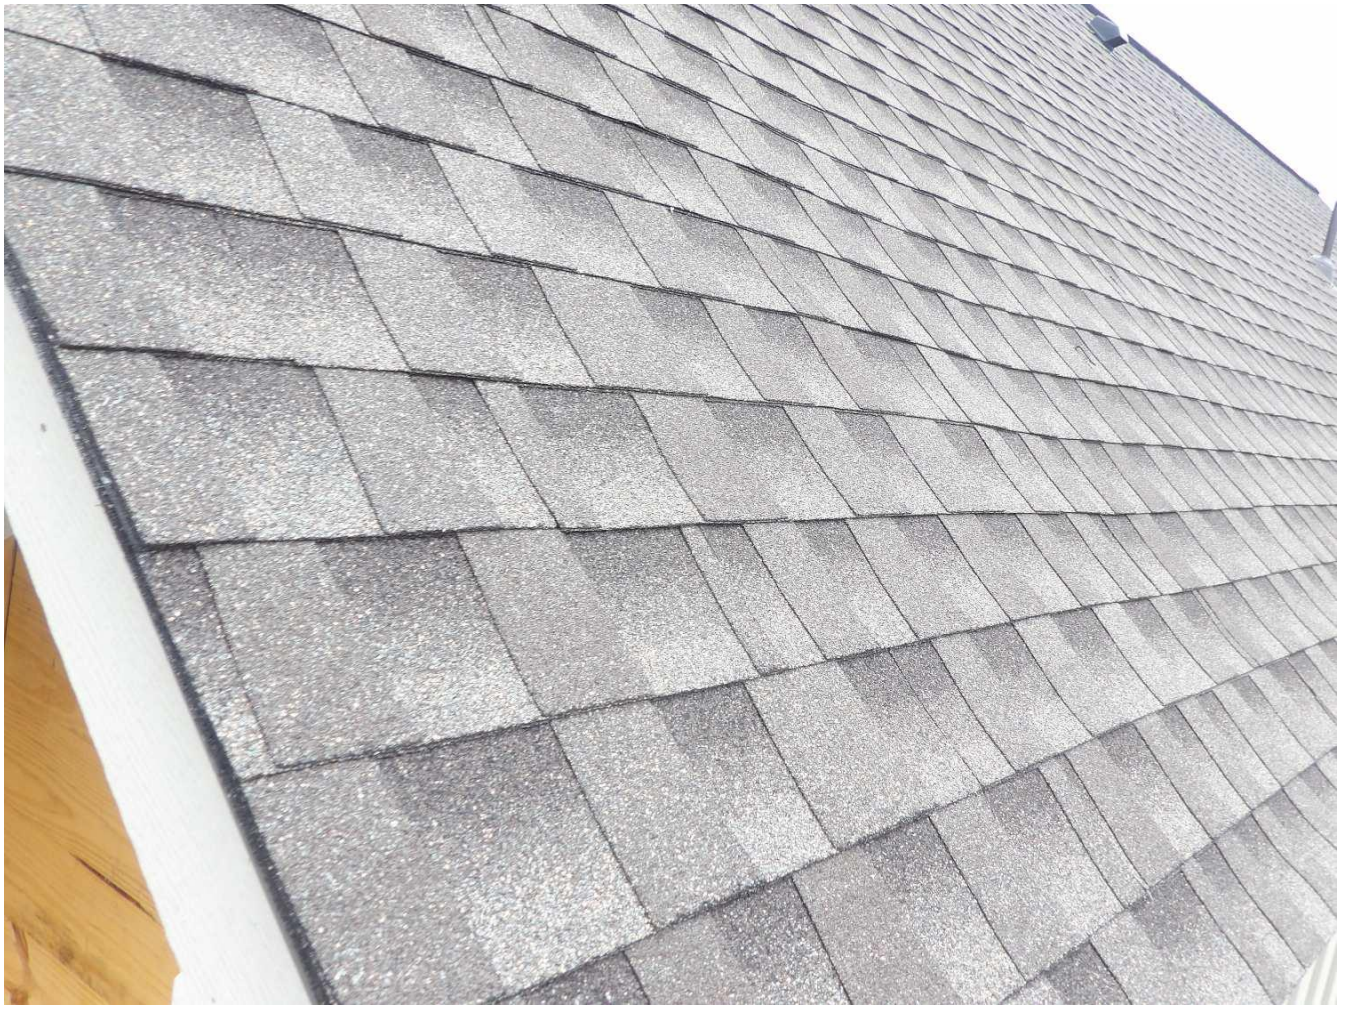
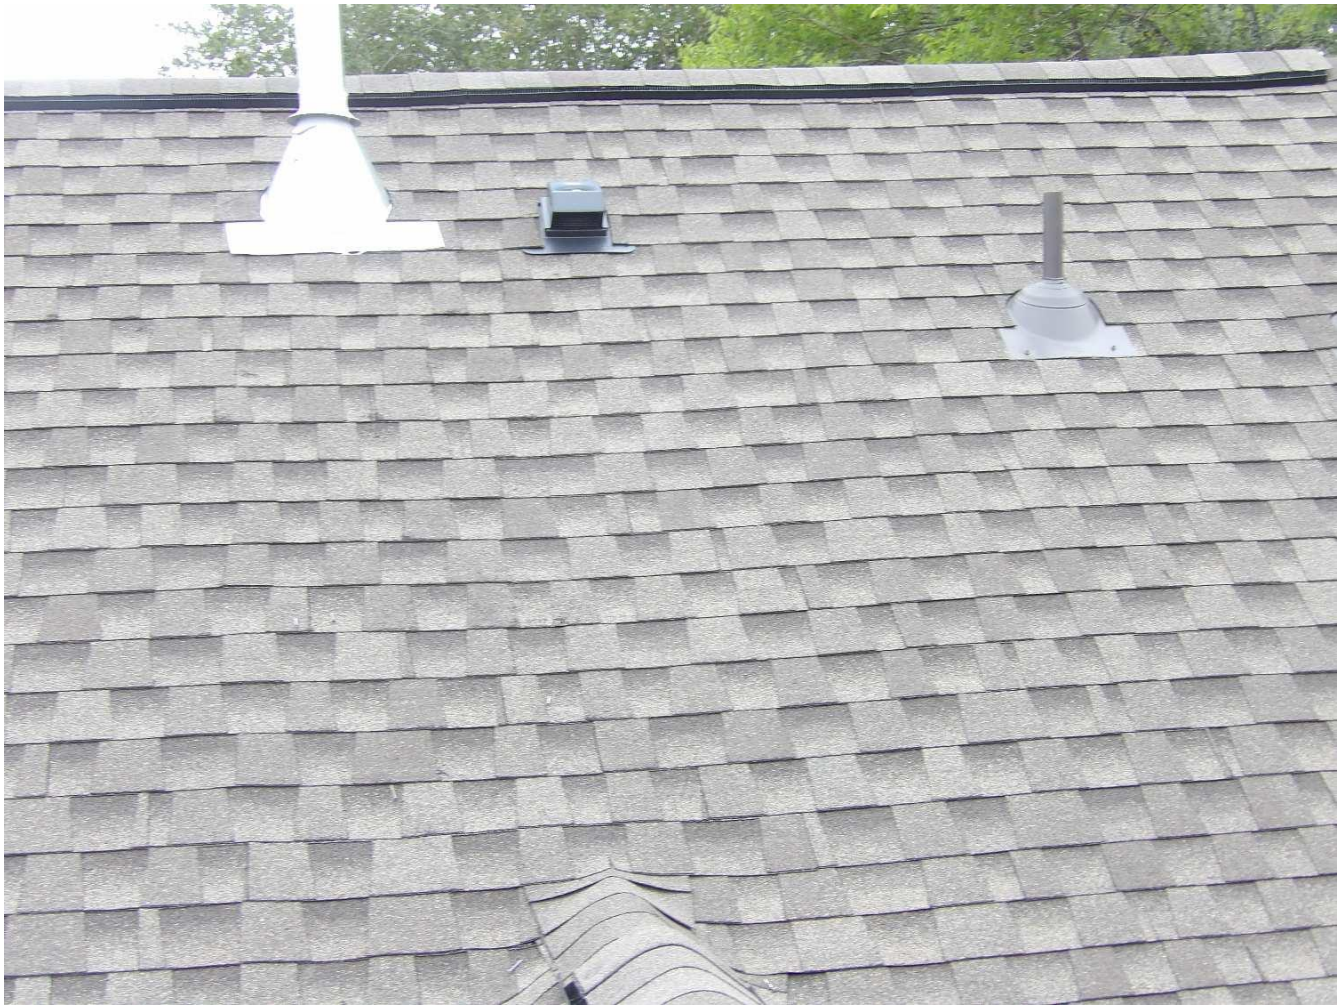
#### **Roof Covering type**

Architectural

### **Roof Covering: Roof Covering Good**

The roof covering was inspected and appears to be in acceptable condition. It is recommended that homeowners practice roof maintenance by keeping the gutters clean, and regularly removing leaves and other debris to allow water to drain effectively from the roof.

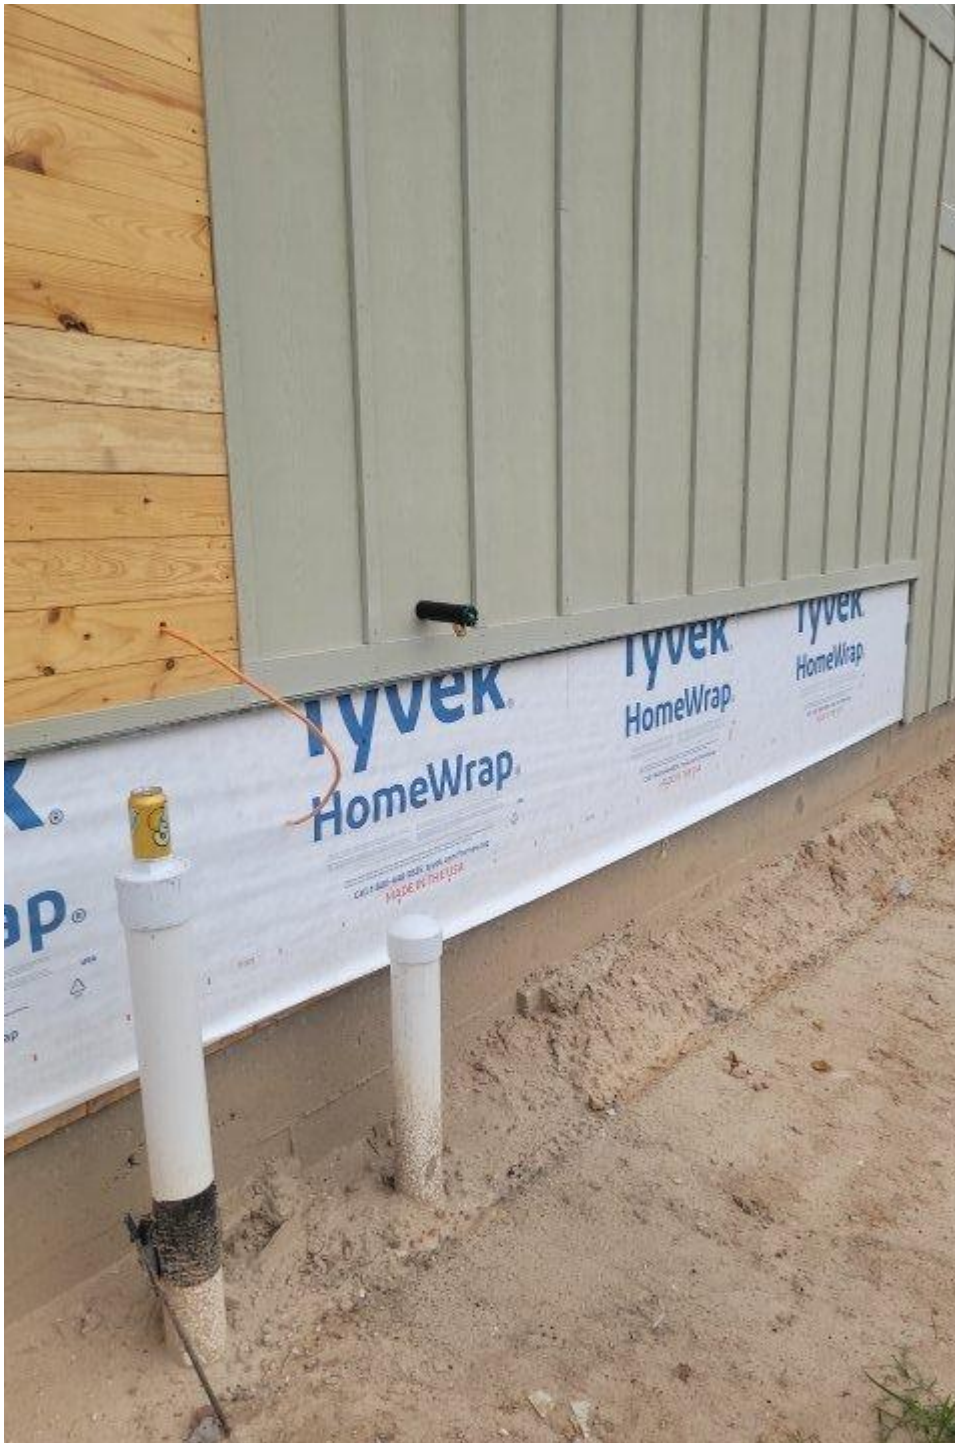
#### **Wall Sheathing: Visual Inspection**

Only the visible areas were inspected at the time of inspection. No deficiencies noted to visible areas unless otherwise noted below.

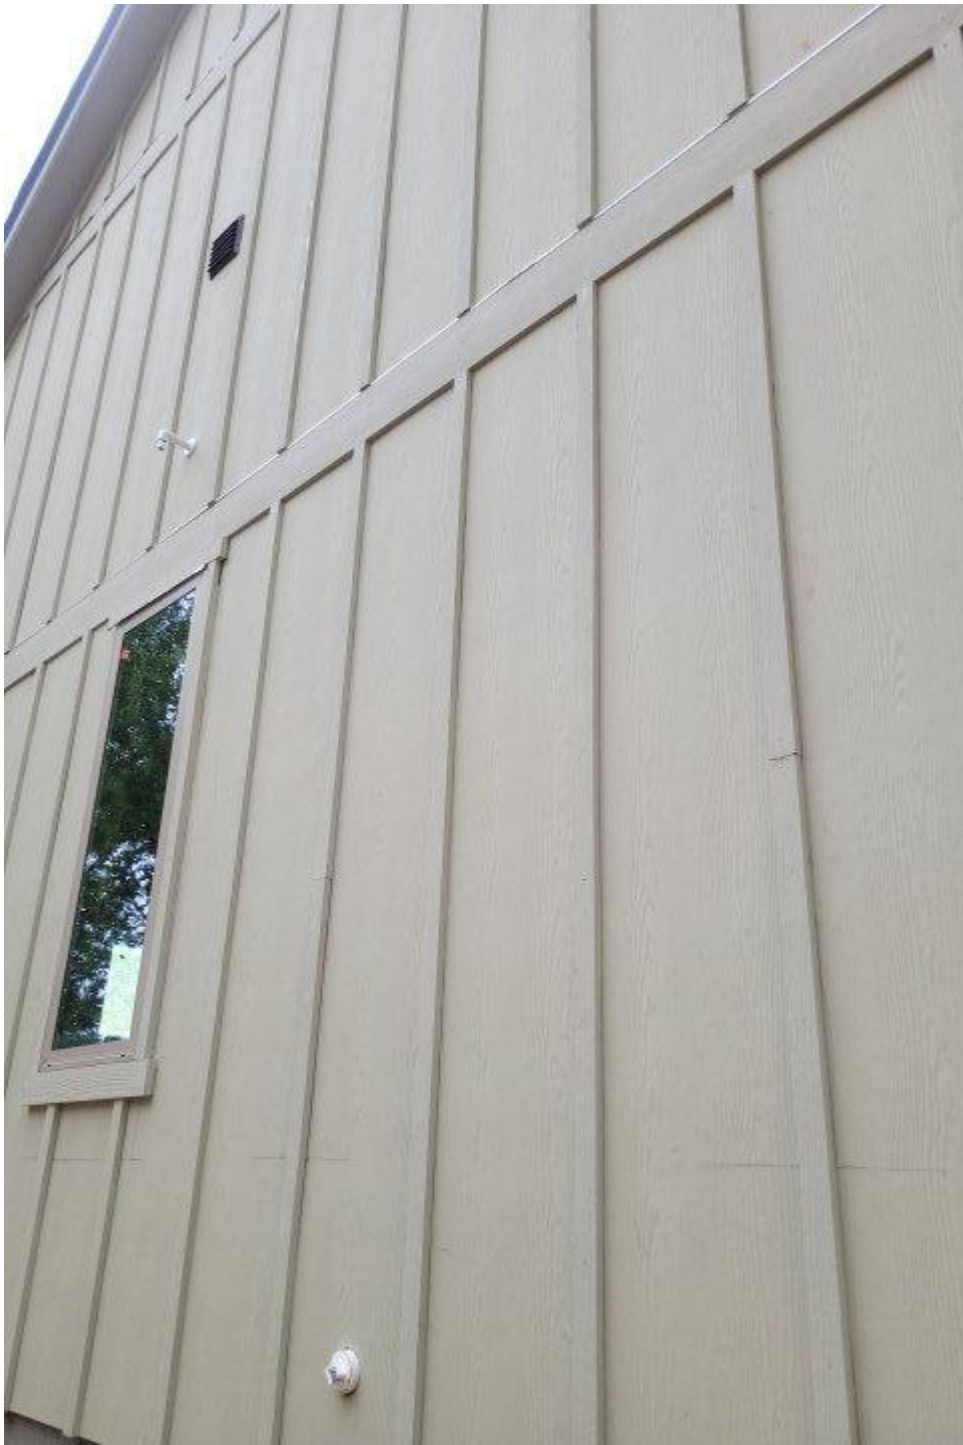
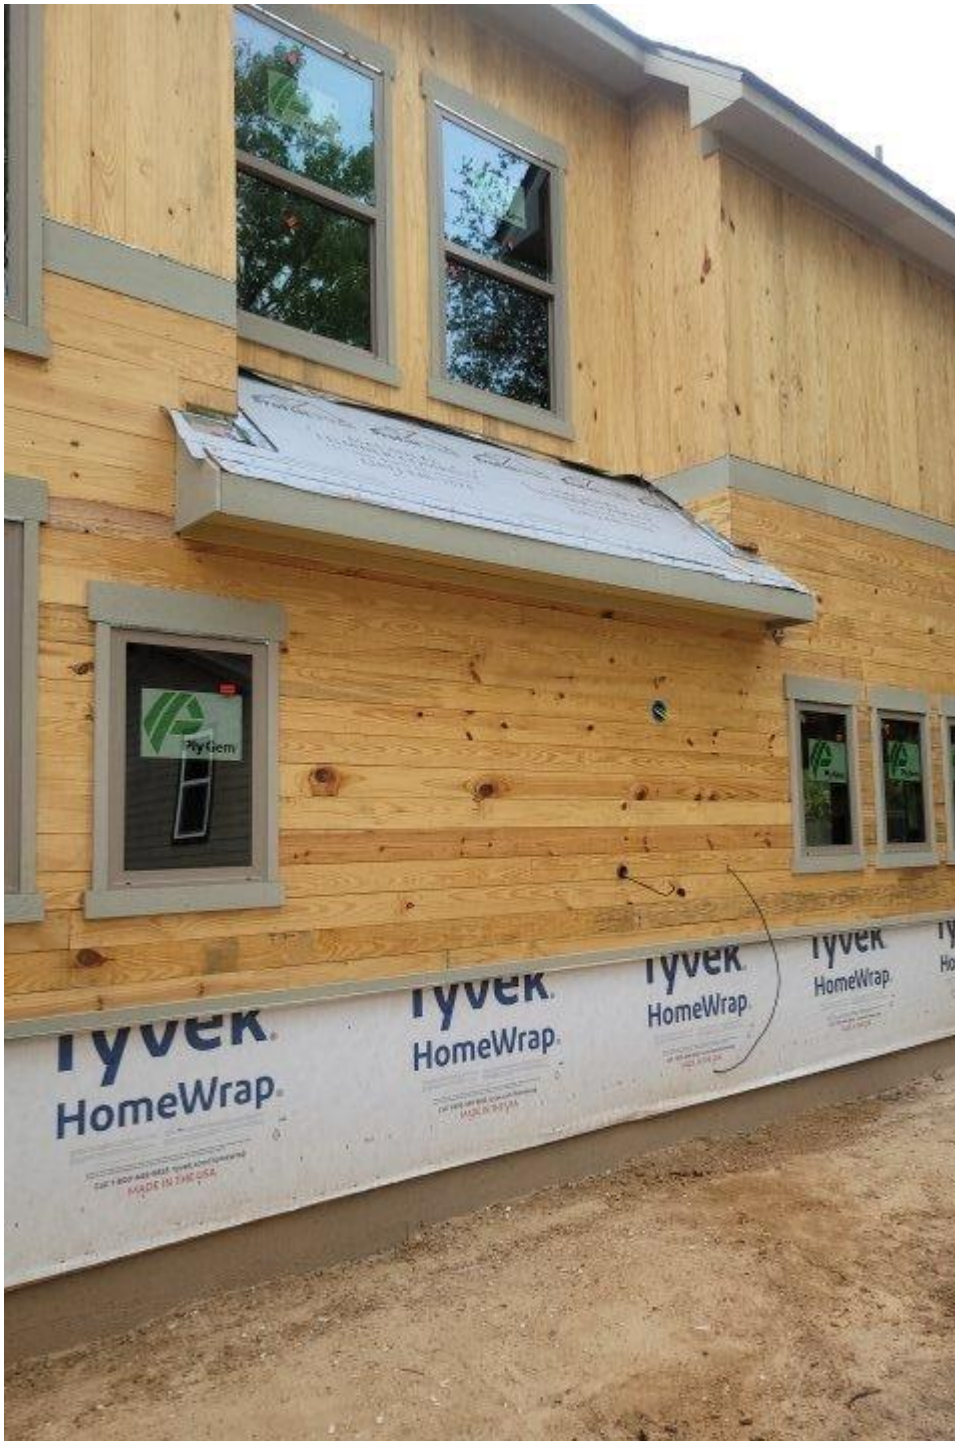
**House Wrap : Siding Installed at time of Inspection**

Siding was installed at time of inspection.

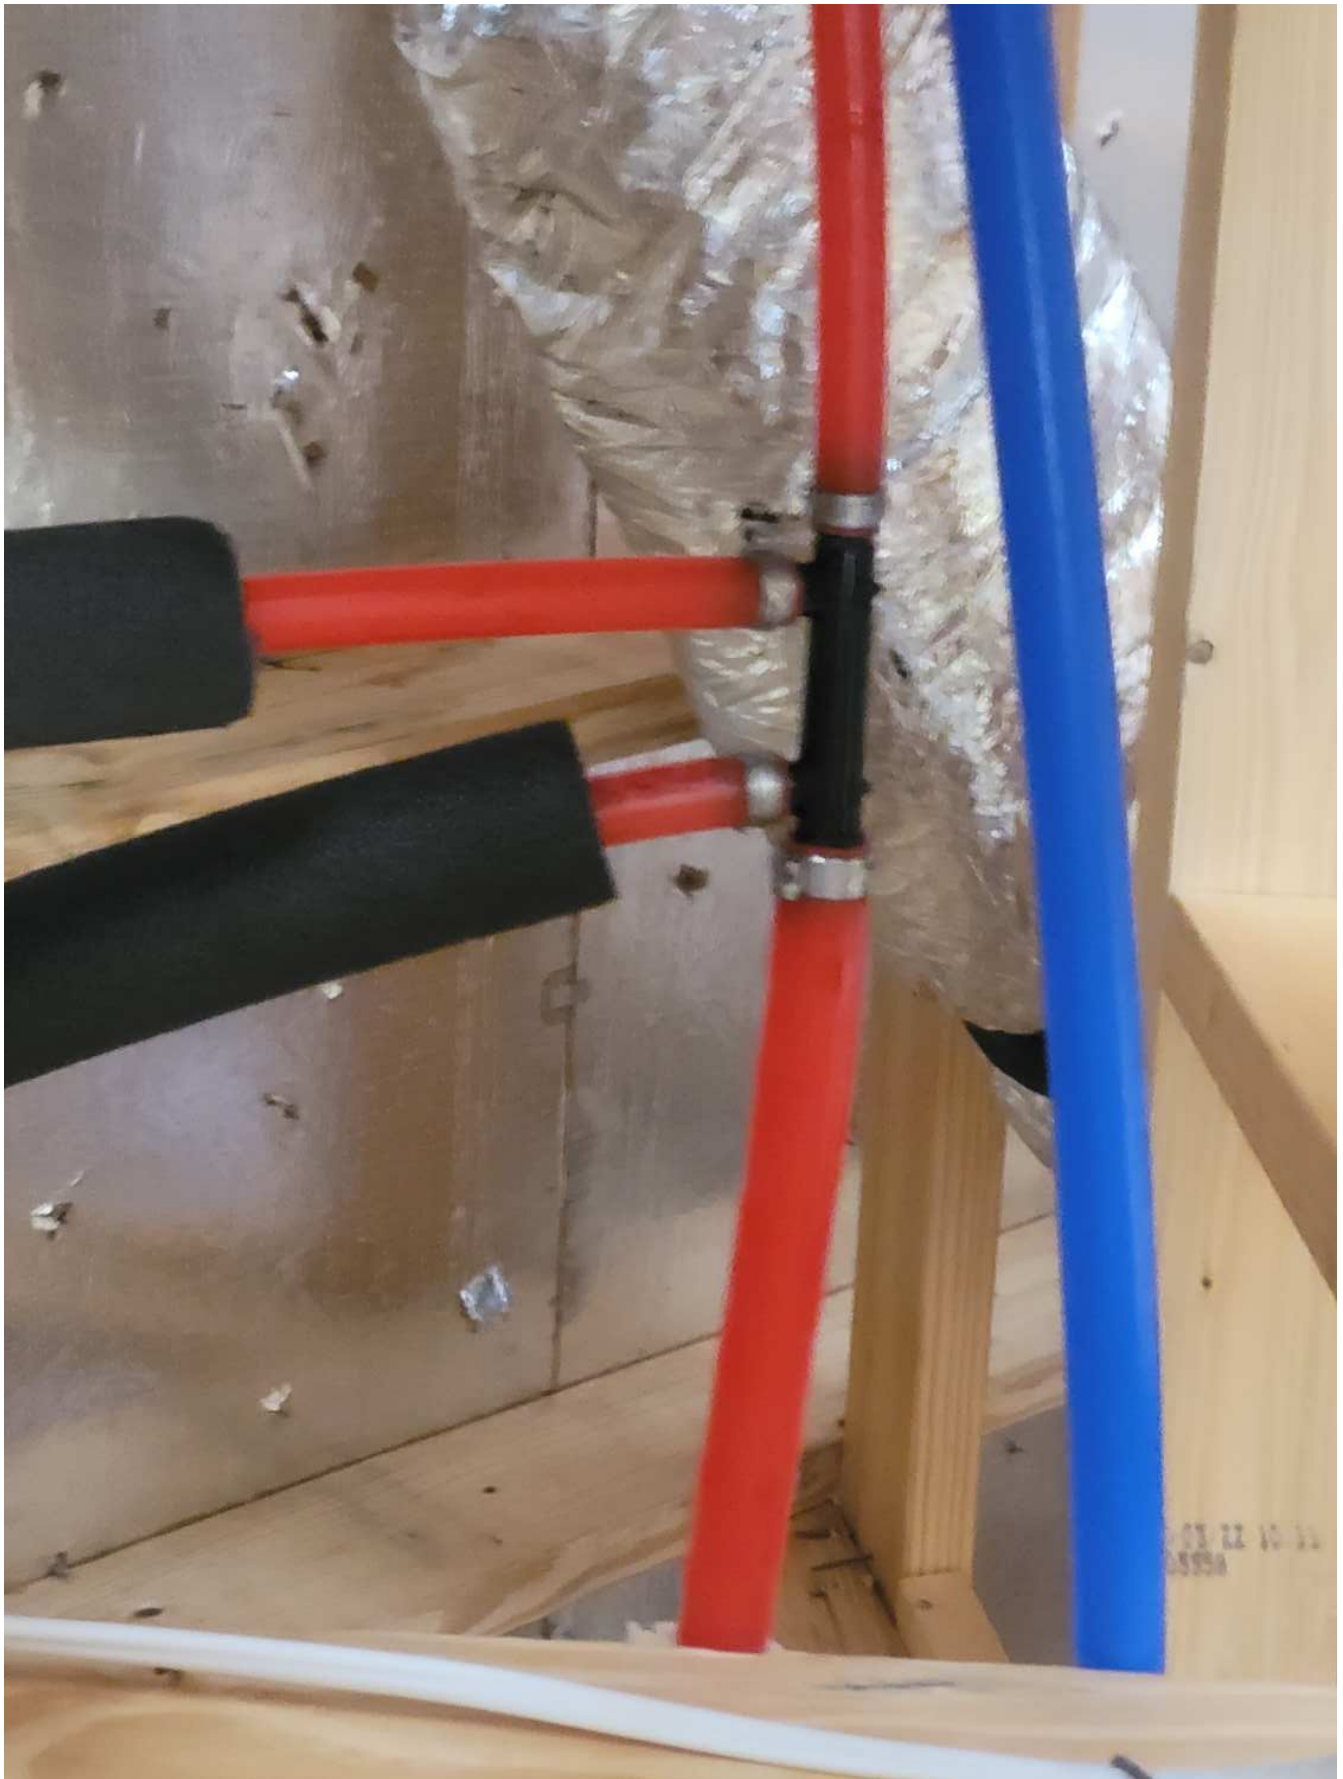
**All Stub Outs Secure: Secured**  
Properly Secured

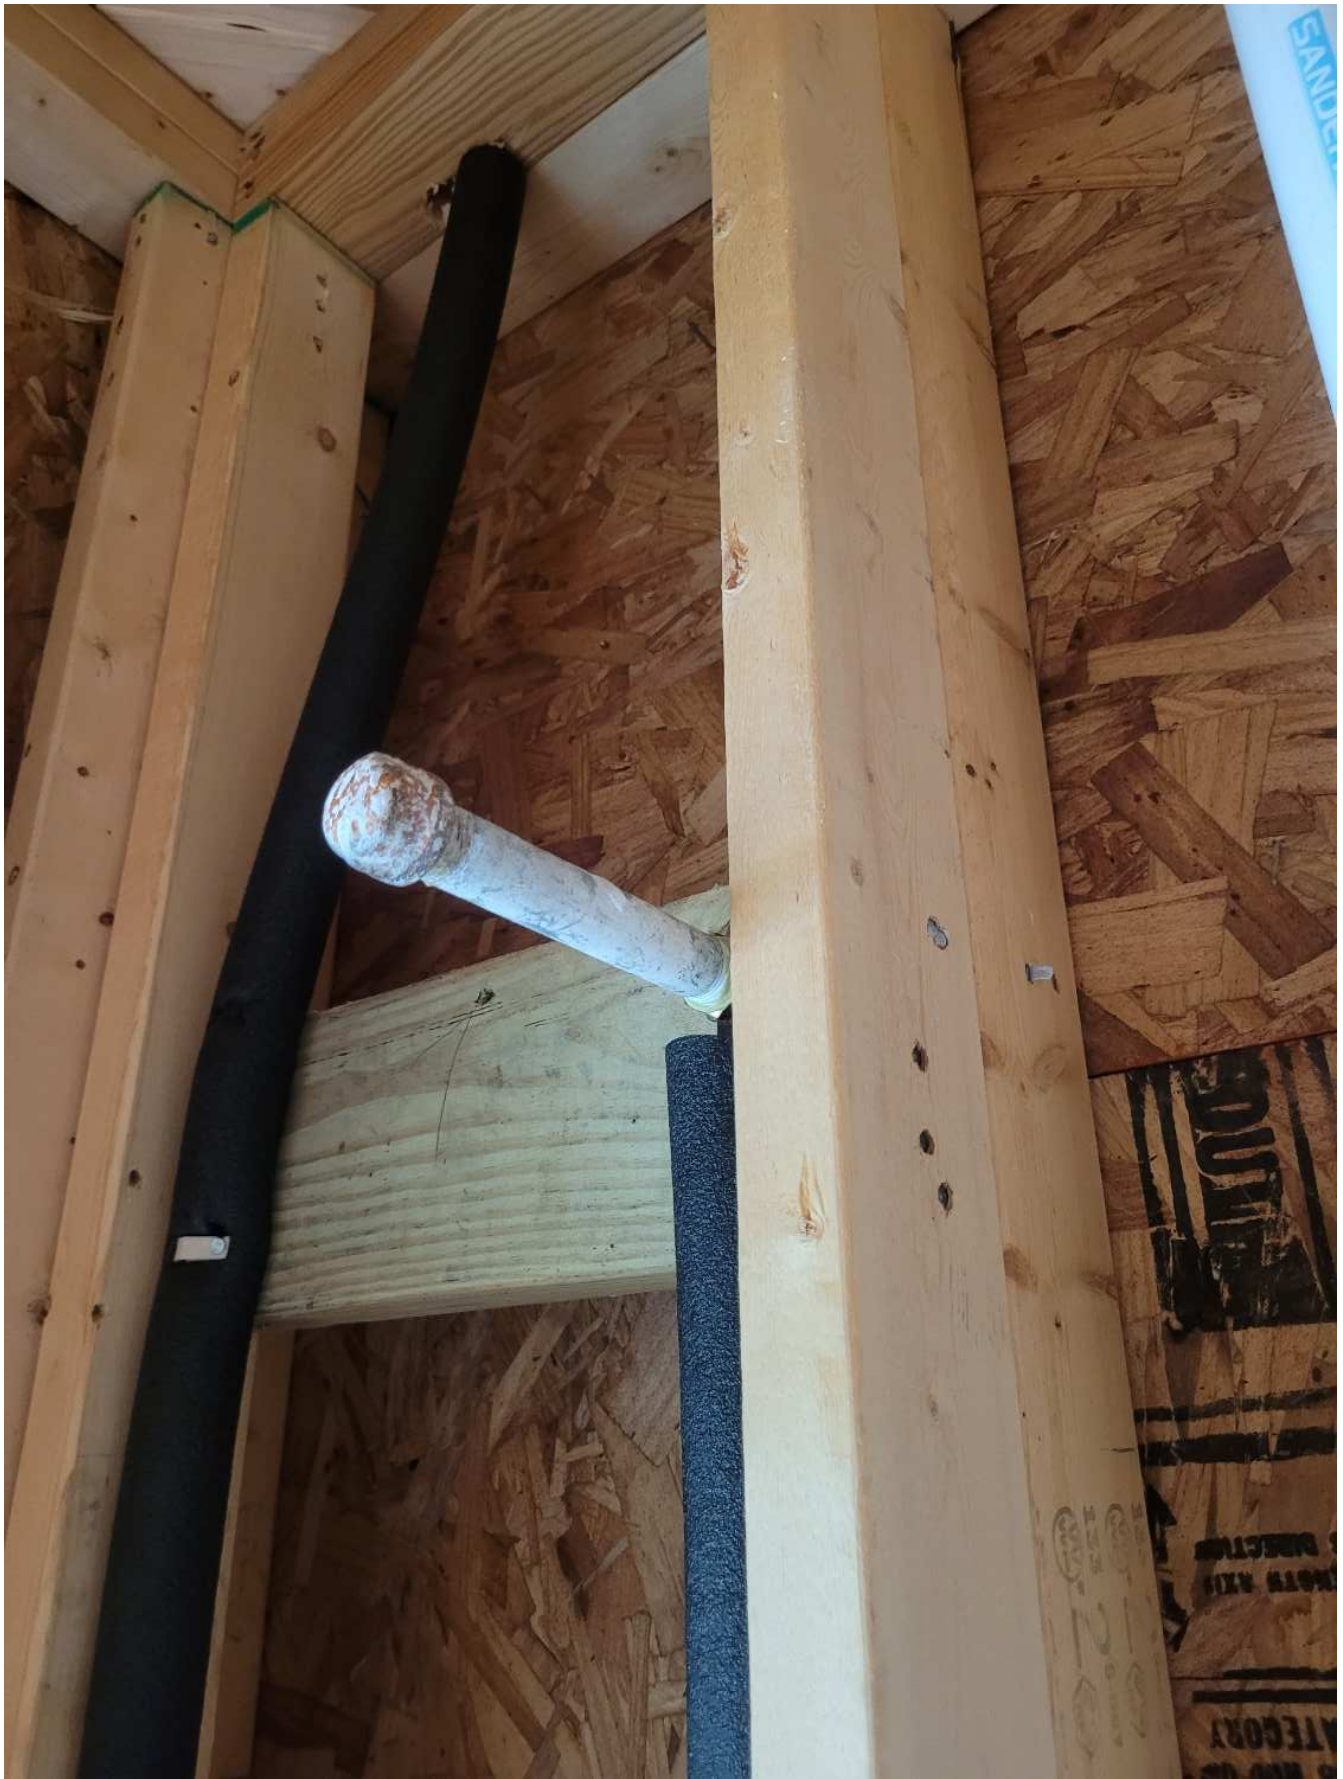
**All Stub Outs Secure: Visual Inspection**

Only the visible areas were inspected at the time of inspection. No deficiencies noted to visible areas unless otherwise noted below.

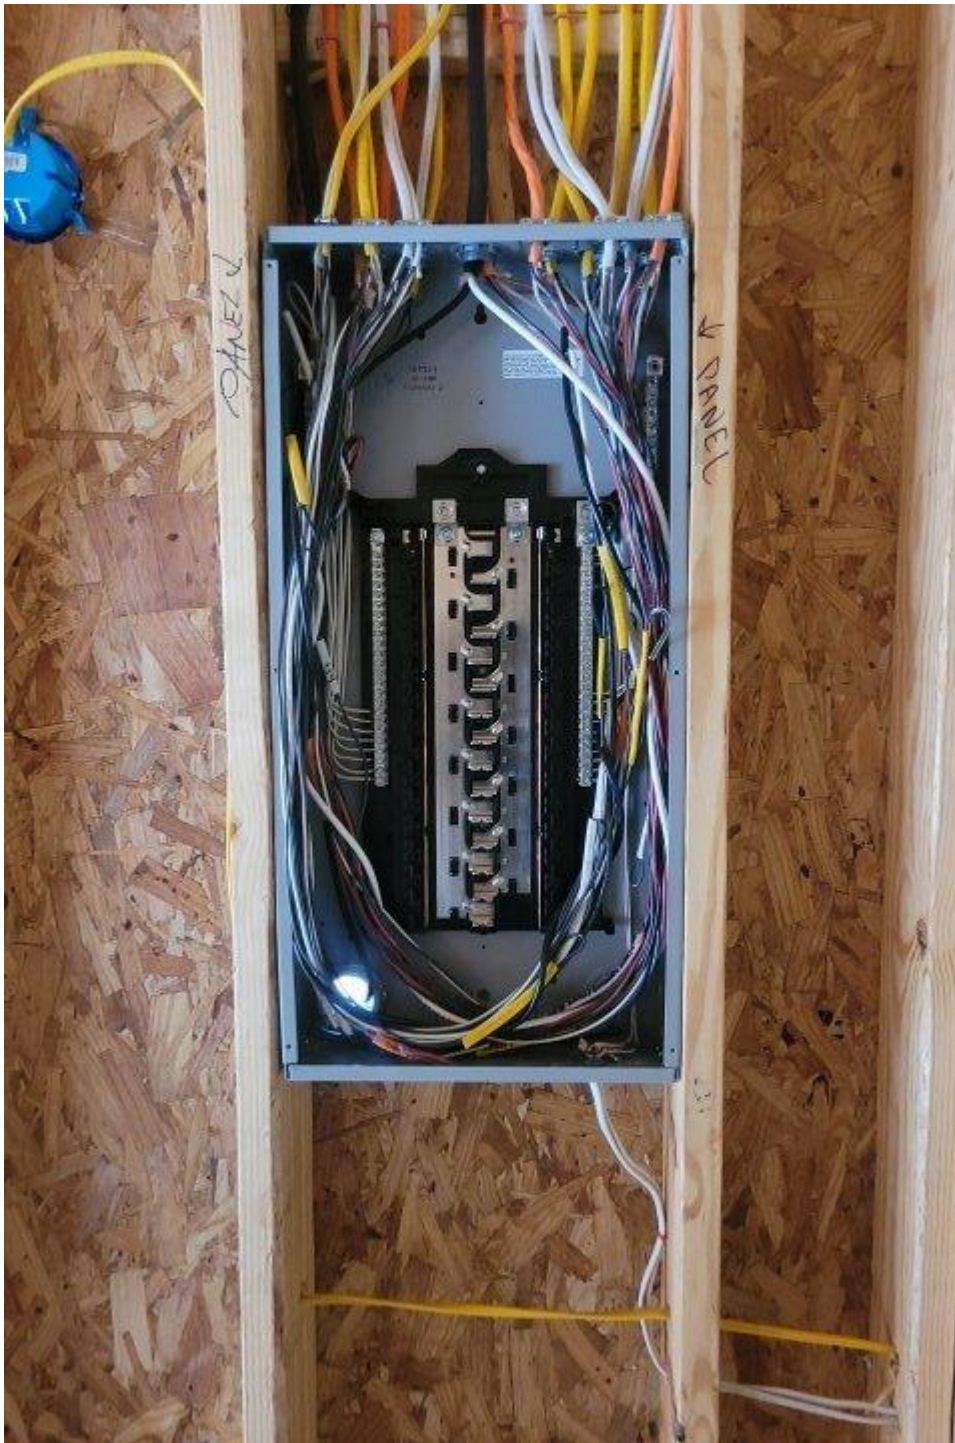
**Electric Panel Manufacturer**

Siemens

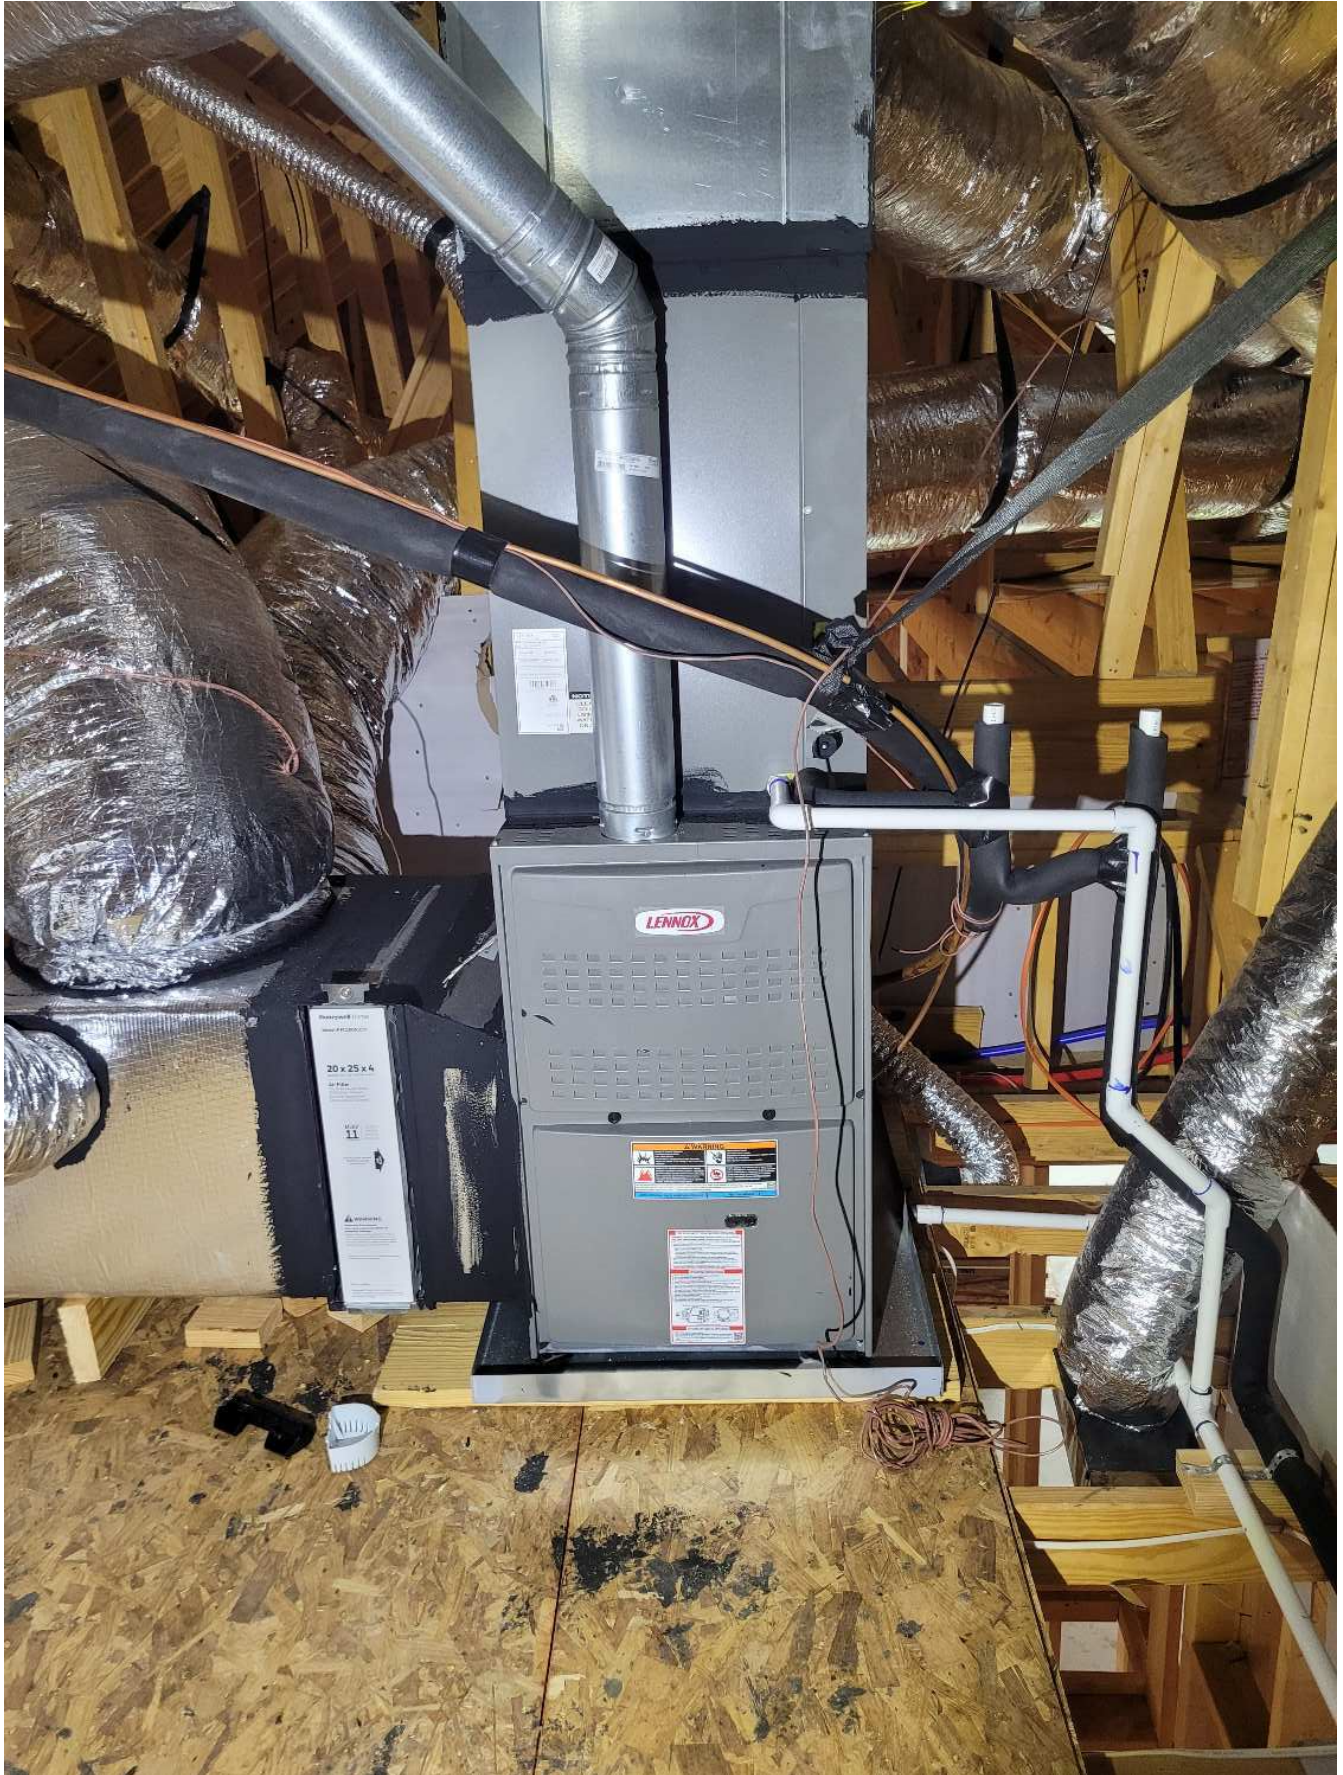
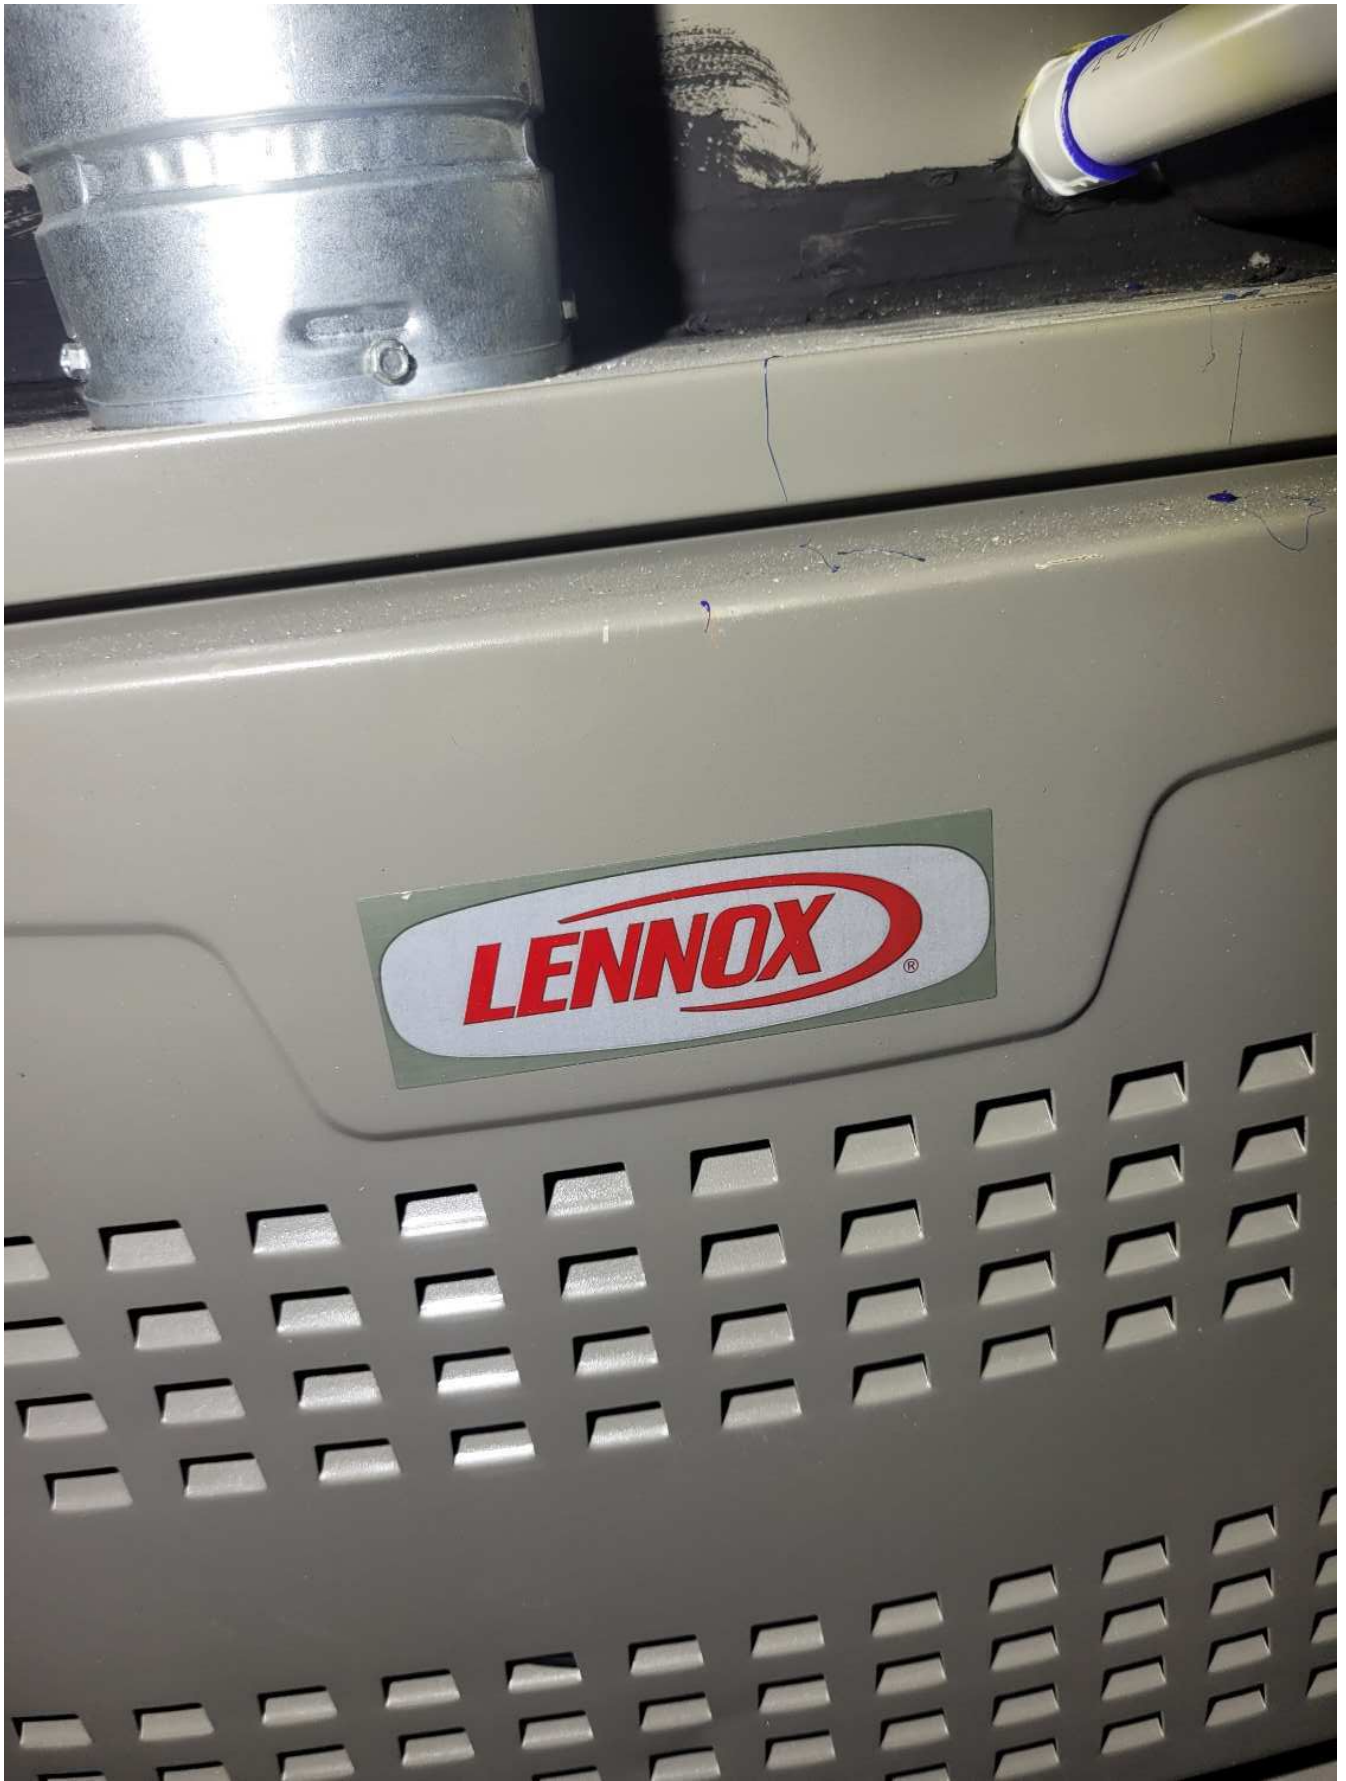
## Presence of installed Heat/Cooling source in each room: Visual Inspection

Only the visible areas were inspected at the time of inspection. No deficiencies noted to visible areas unless otherwise noted below.

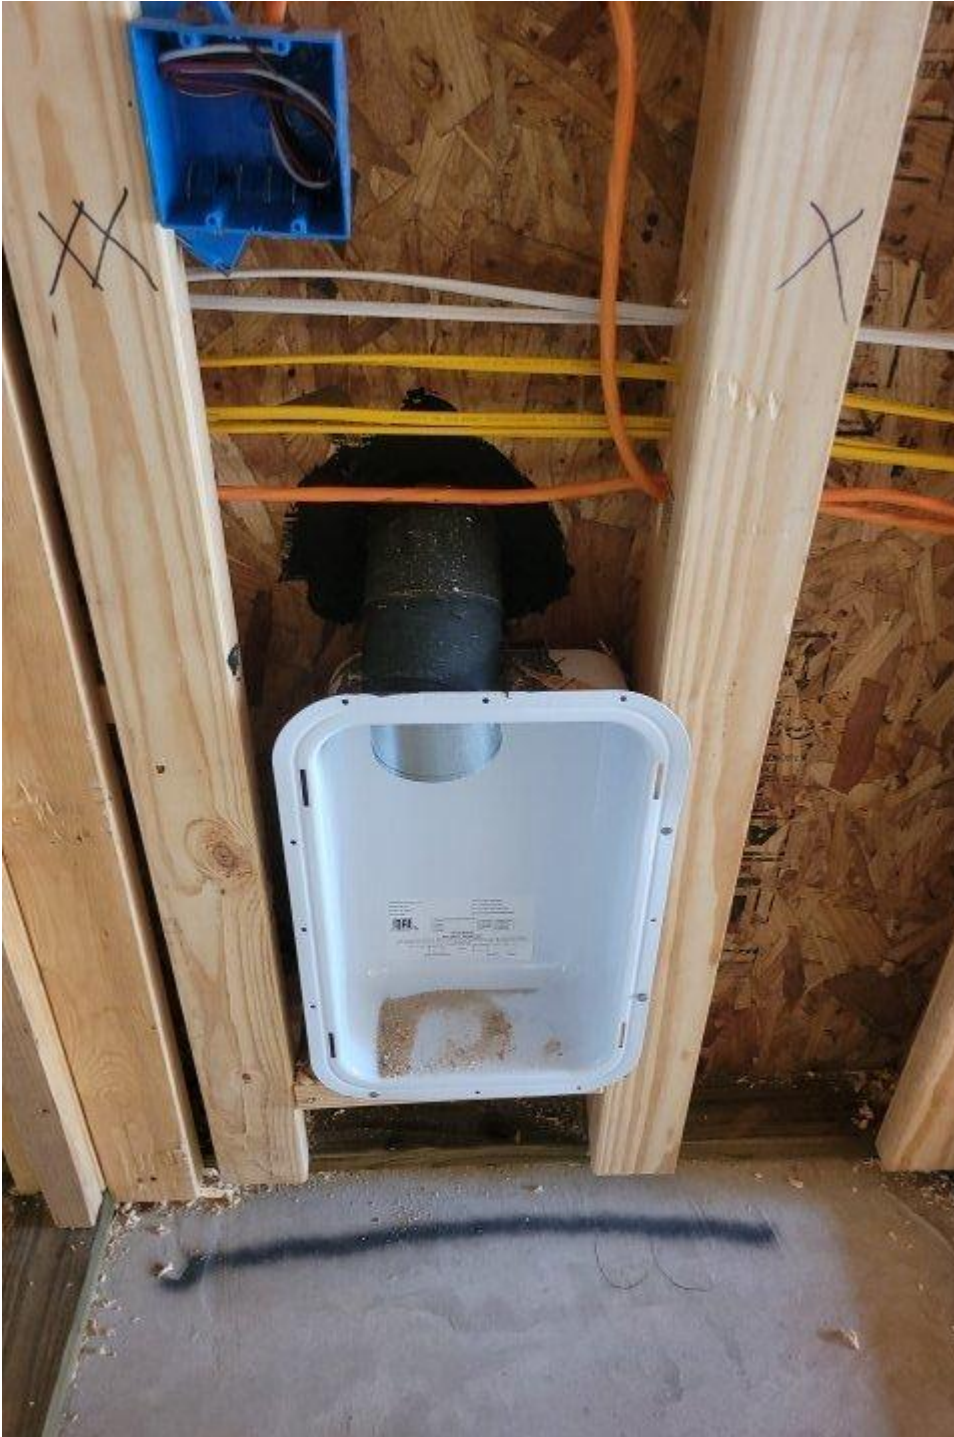
#### **Dryer Vent Installed and Properly Sealed & Terminated: Visual Inspection**

Only the visible areas were inspected at the time of inspection. No deficiencies noted to visible areas unless otherwise noted below.
