# HOME INSPECTION SERVICES INC.

10 Hunters Creek Dr  
Huntsville, TX 77340  
08/26/2022 9:30 am

Inspector  
Raymond Bennett  
TREC#24071

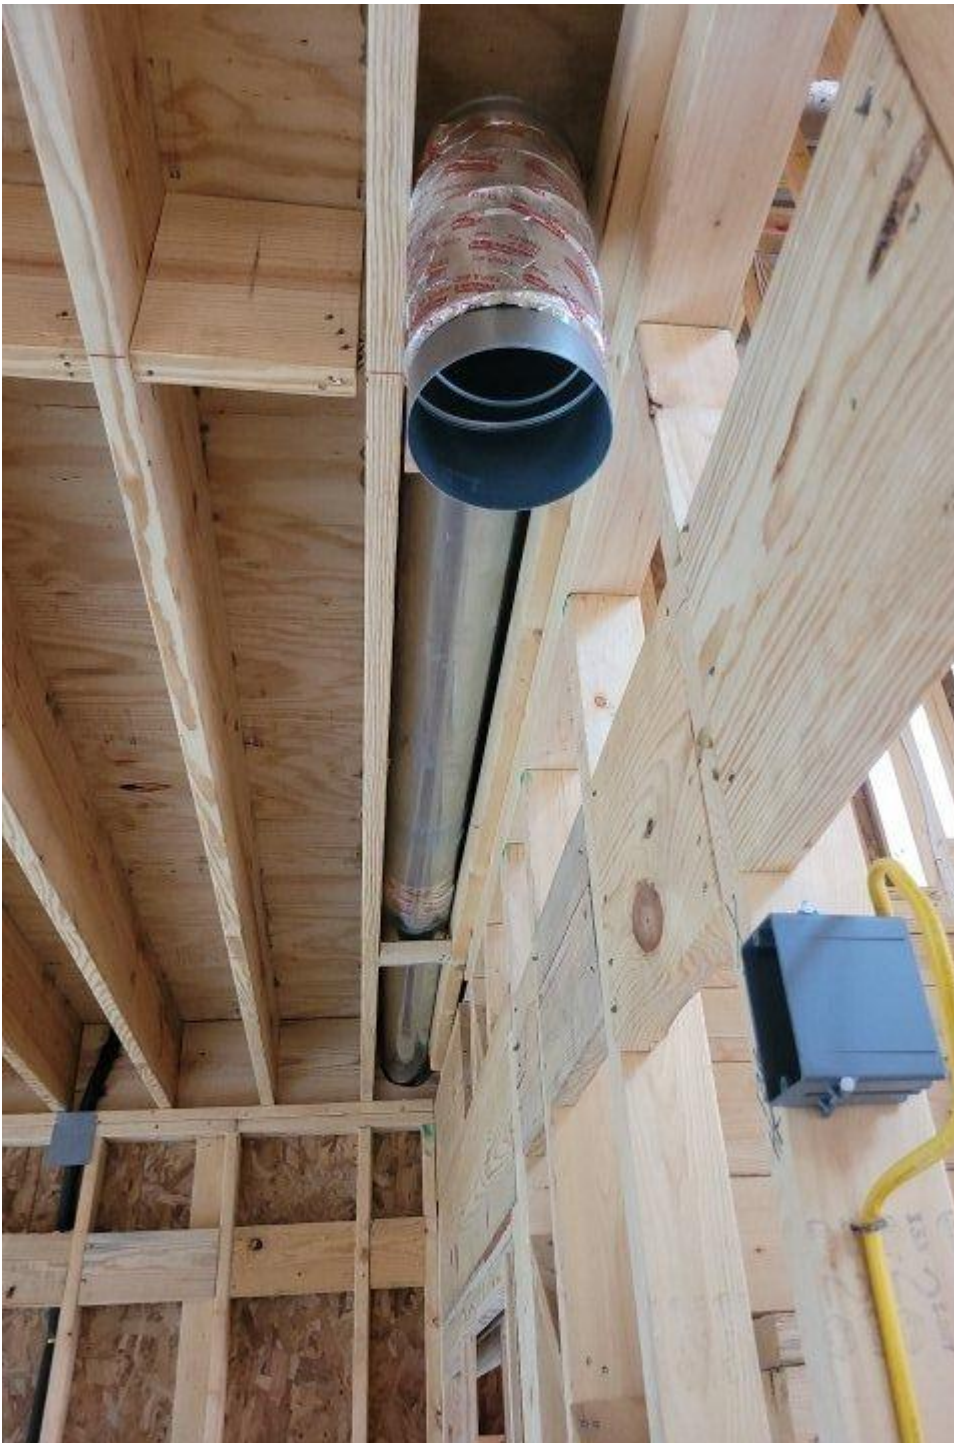
#### **Hood Vent: Visible Inspection**

Only the visible areas were inspected at the time of inspection. No deficiencies noted to visible areas unless otherwise noted below.

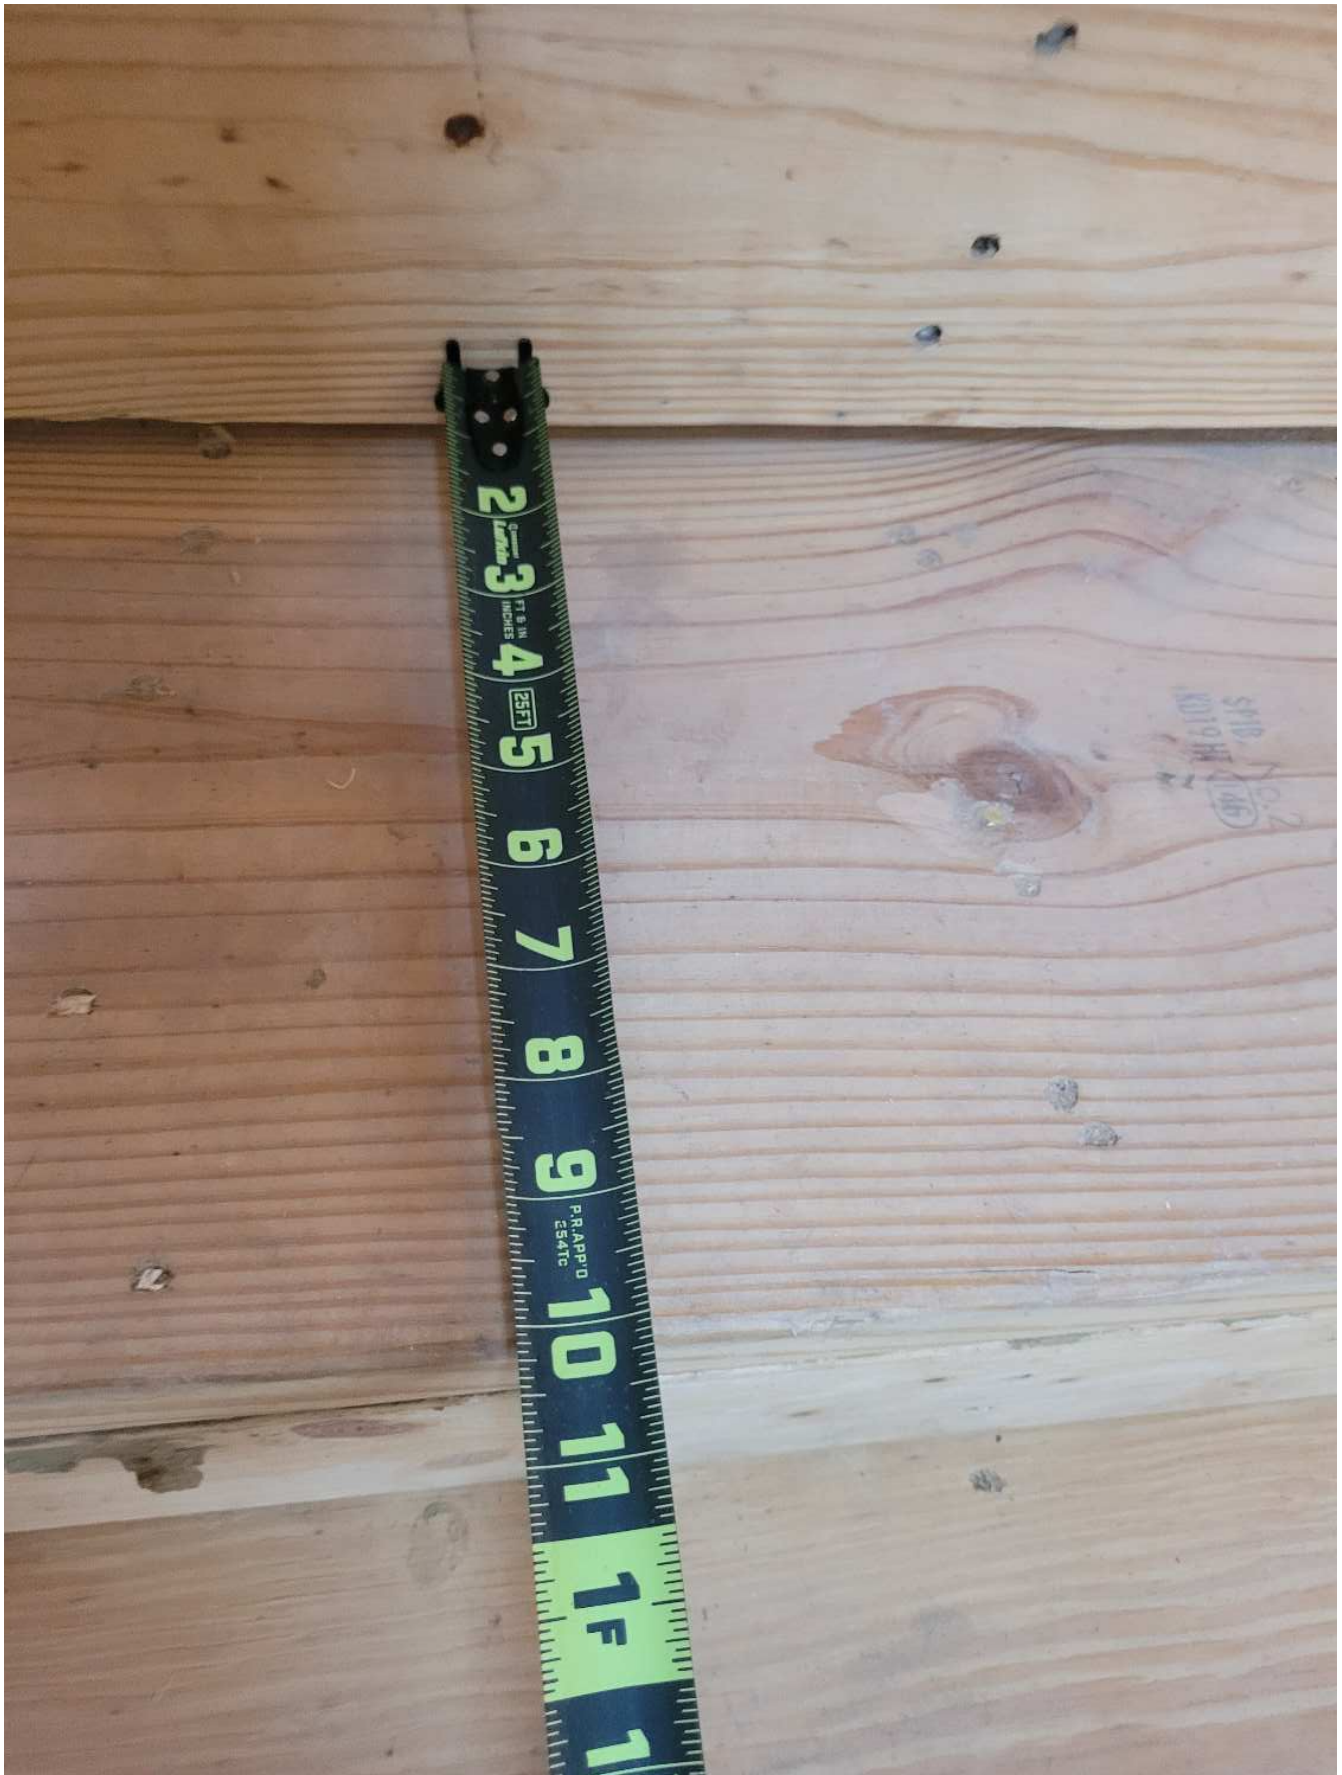
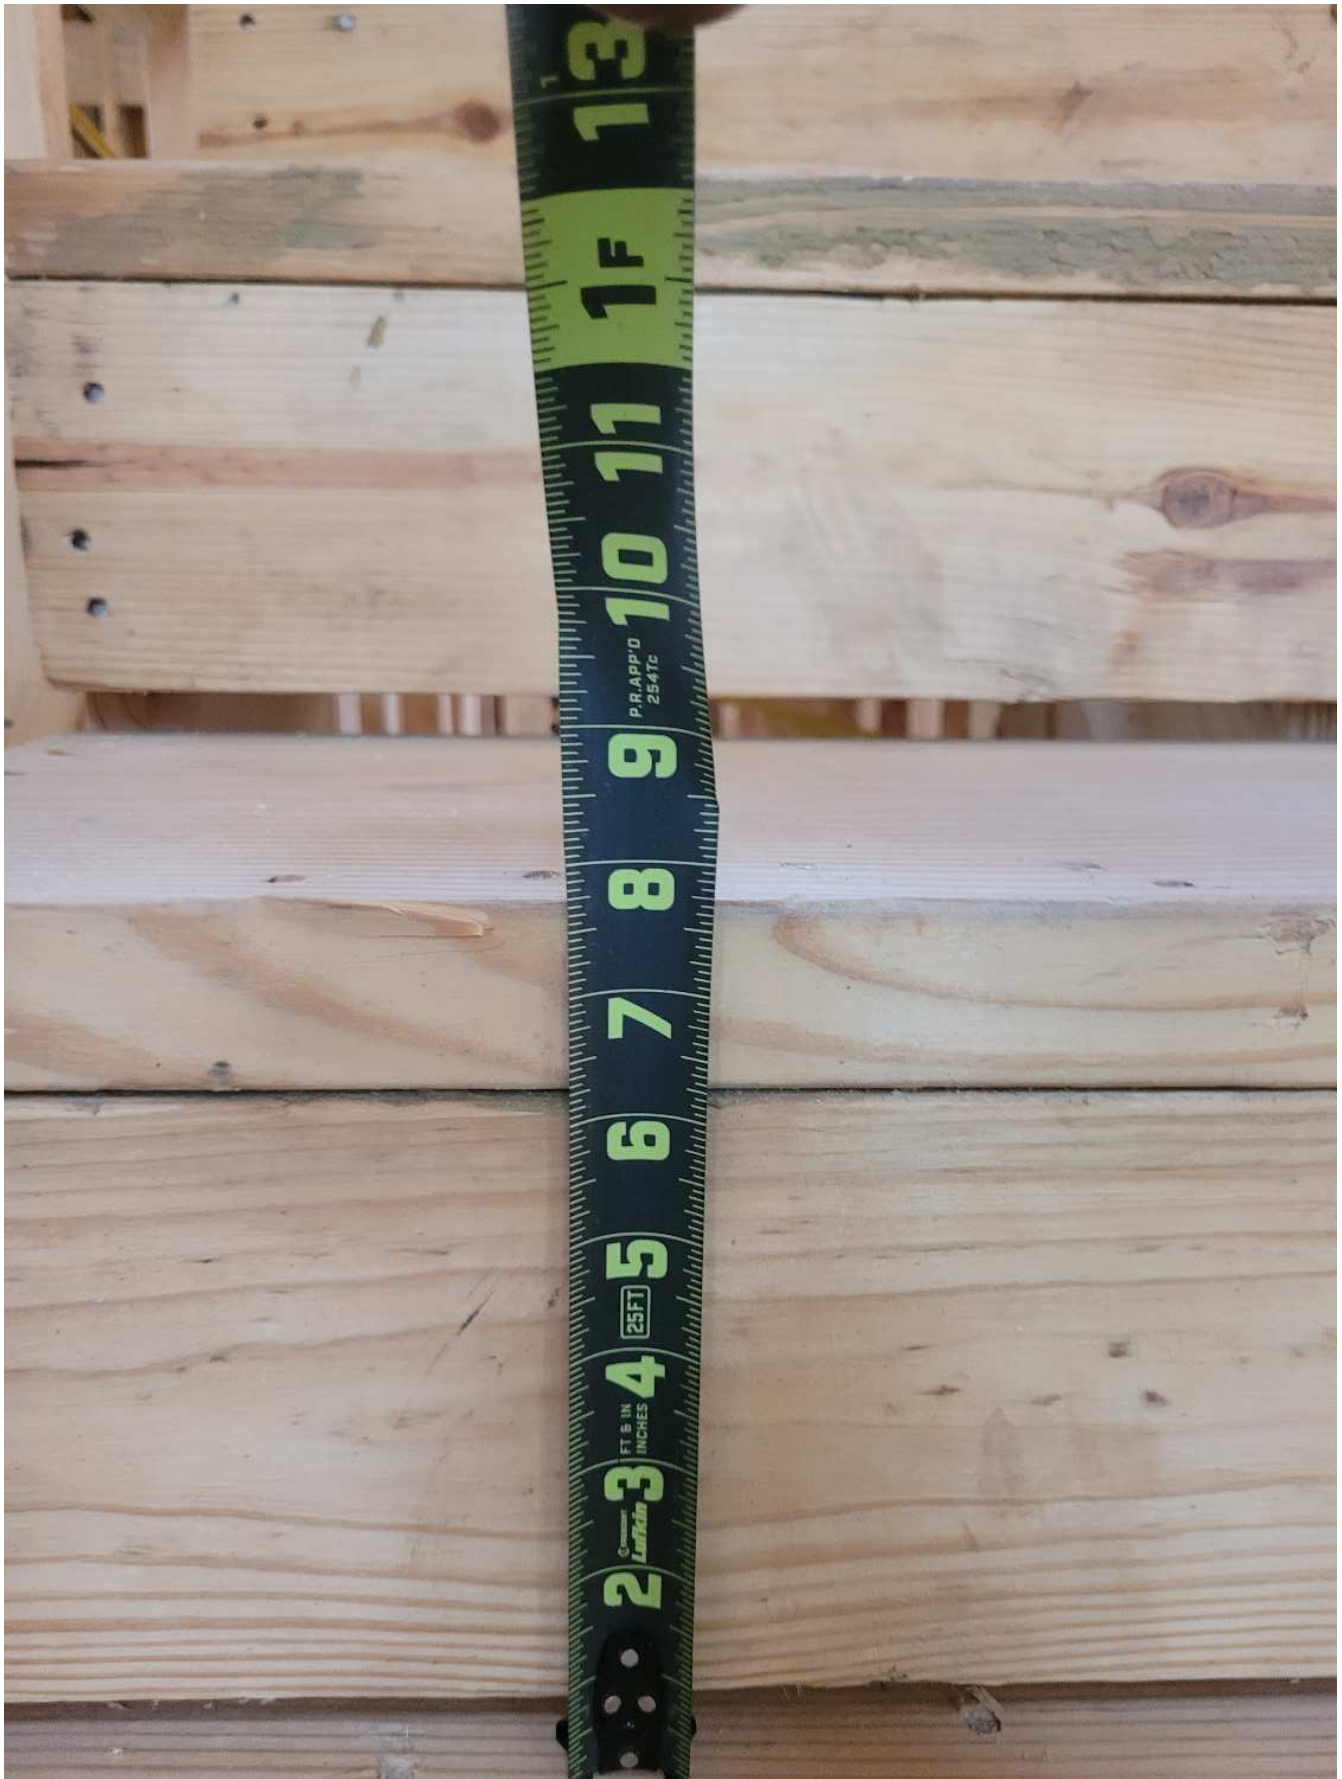
**Stairs, Steps, Landings, Stairways & Handrails: Visually Inspected**

Only the visible areas were inspected at the time of inspection. No deficiencies noted to visible areas unless otherwise noted below.

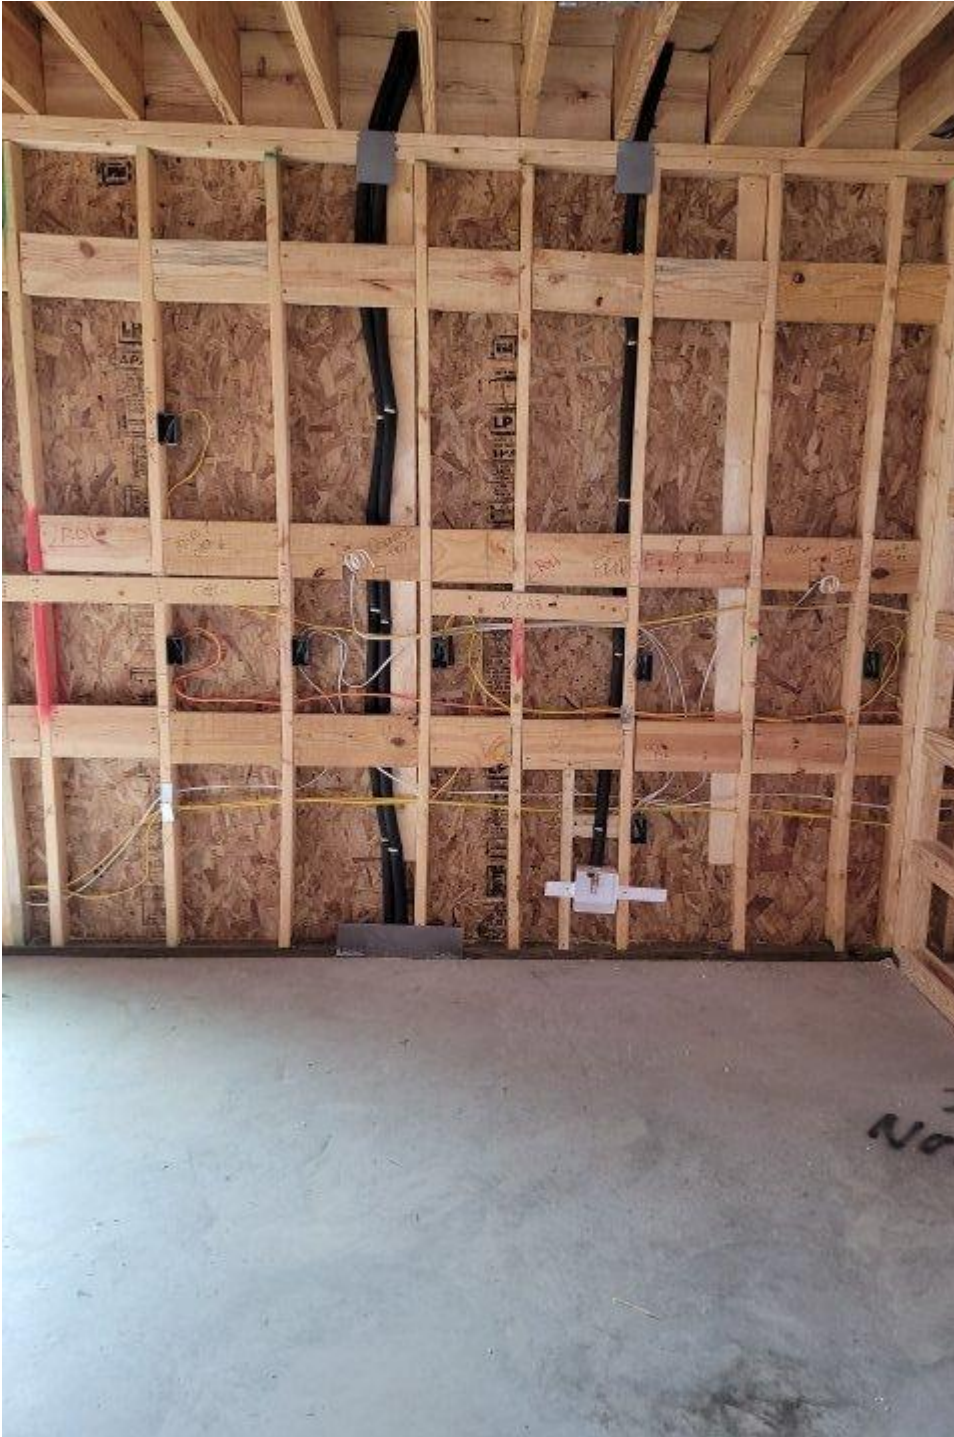
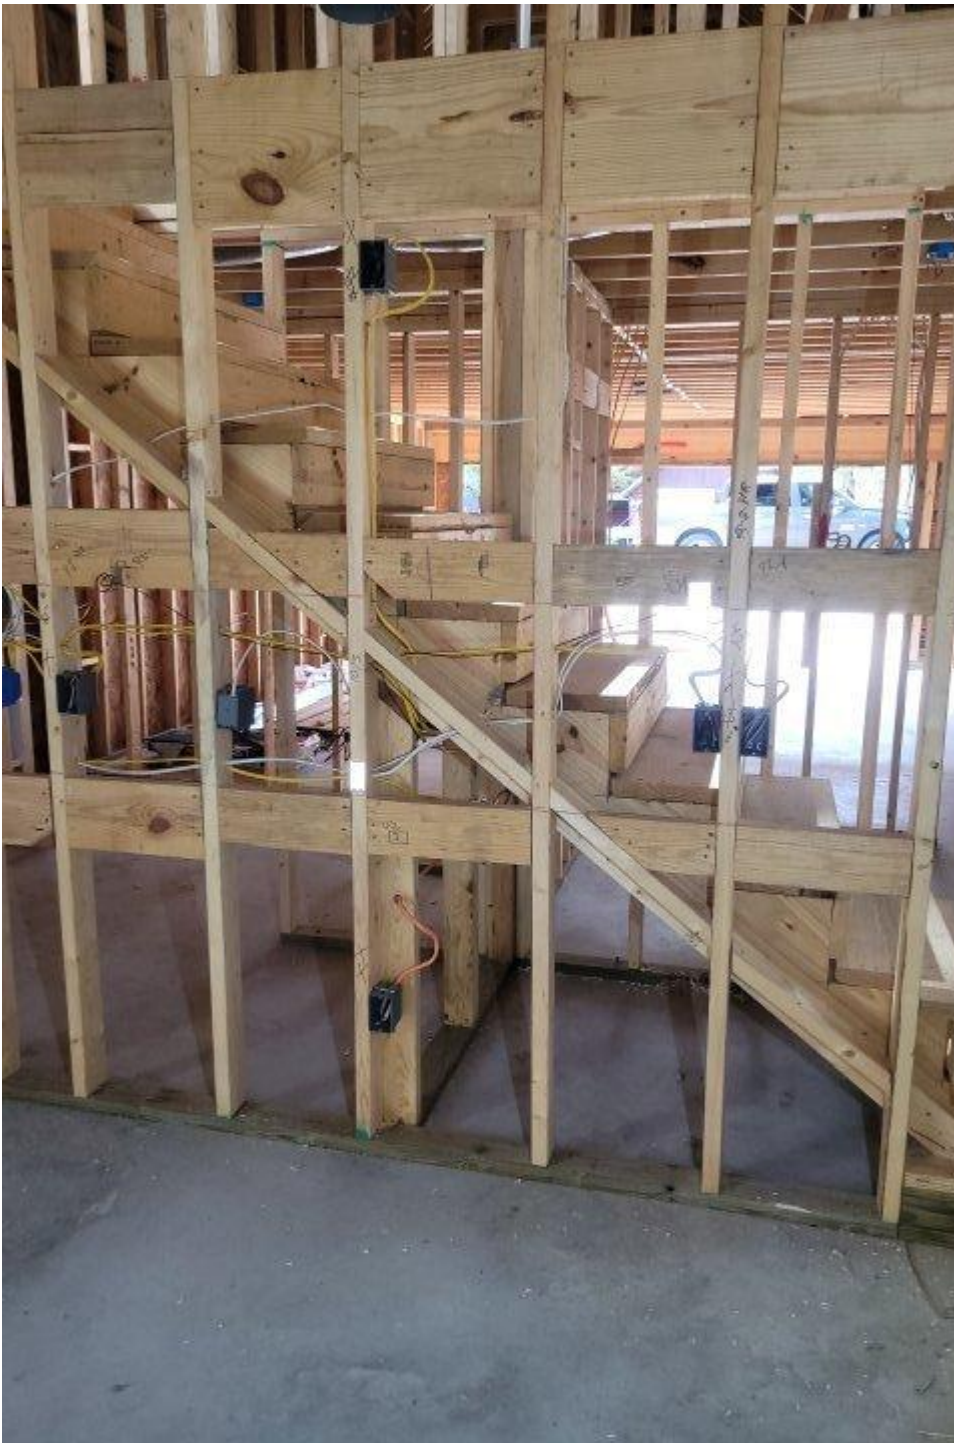
Only the visible areas were inspected at the time of inspection. No deficiencies noted to visible areas unless otherwise noted below.

This is not required by the Builder but a good recommendation to allow the towel bars, toilet paper holders etc to be secured better and prevent damage later during normal use.
